Buoyancy Effect on Slightly Sloped Horizontal In-Place Inclinator

Charles George; Niels Jensen, P.E., PhD

GZA GeoEnvironmental, Inc.

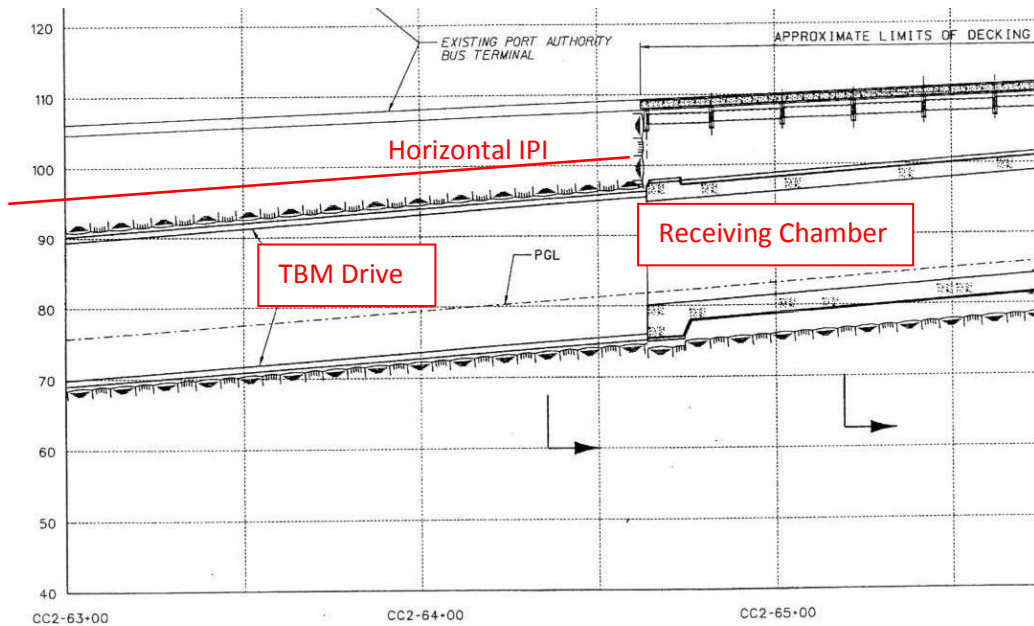
The IPI borehole was drilled into a vertical rock face from the receiving chamber, parallel to the tunnel alignment, 1 meter above its expected path (Figure 4). At this location, the Tunnel Boring Machine (TBM) path slopes up towards the receiving chamber at a 3% grade. The seemingly logical decision to drill parallel to the tunnel drive, dipping slightly down from the borehole opening, was an unfortunate one that created several problems described below.

Figure 4. Location of IPI above tunnel, drilled from receiving chamber.

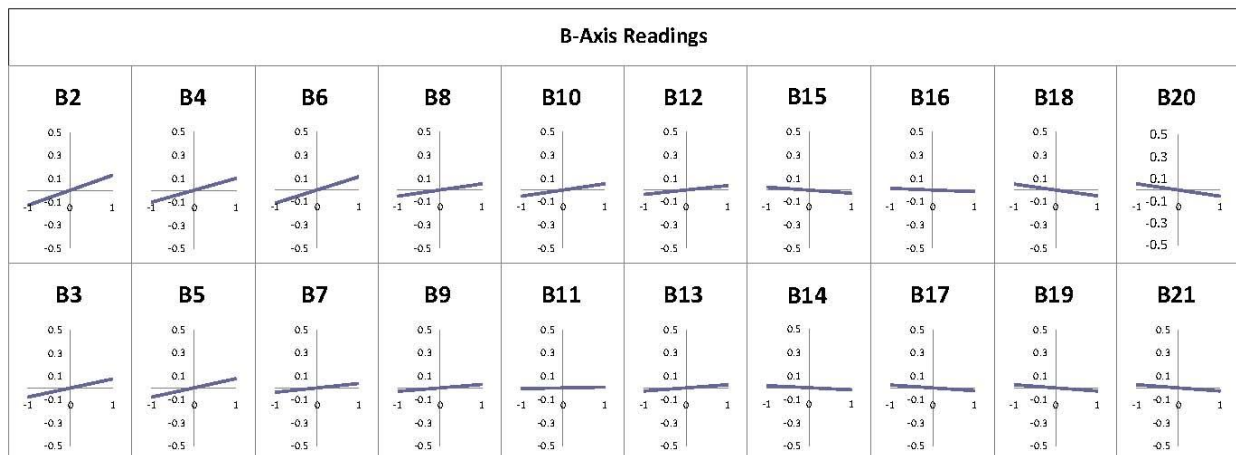
The instrument and casing were removed and reinstalled correctly, with documented tolerance of less than 5% rotation at any point along the borehole (Figure 6). The casing was then grouted into place via a tremmie pipe that had been installed together with the casing.

Figure 6. B-axis tilt, verifying sensor orientation within 5% tolerance.

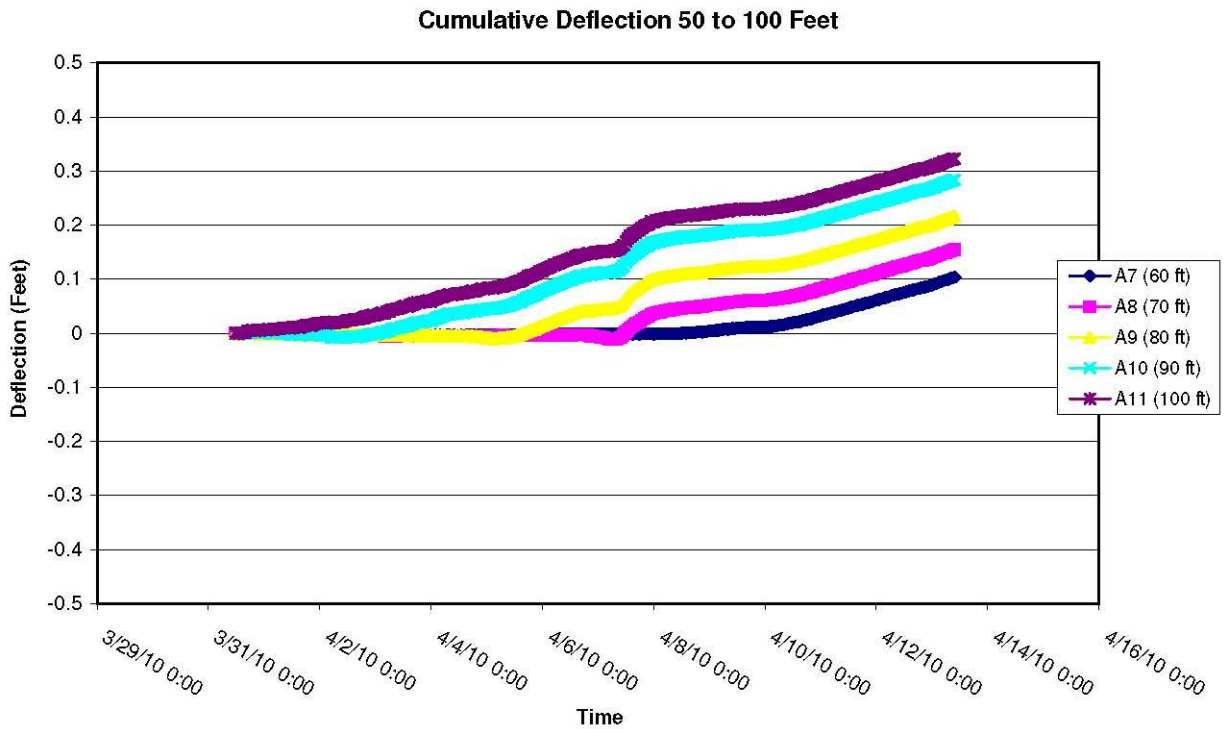
No movement was expected before tunnel excavation beneath the instrument and low thresholds were set for movement alarms. However, over a period of several weeks, long before excavation reached the instrument, apparent displacement began to register in each element, one at a time from the deepest to the shallowest (Figure 8).

Figure 8. Plot showing apparent movement in sensors progressively along the borehole.

No actual settlement had occurred, and it was ascertained that the apparent displacement was caused by the casing slowly filling with water due to small leaks through the grout and casing joints. Due to the downward slope, the far end of the borehole filled first. As each element was progressively submerged, the buoyancy of the hollow, air-filled spacer rod caused very small bending and tilt of the sensors in precisely the orientation they were designed to detect (Figure 9). This tilt was automatically converted to displacement according the assumptions of the data processing described in Figure 3. Less than half of one degree of tilt is sufficient to produce the apparent displacements, which were over 1 foot (0.3 meters) when added together over the entire length of the instrument.

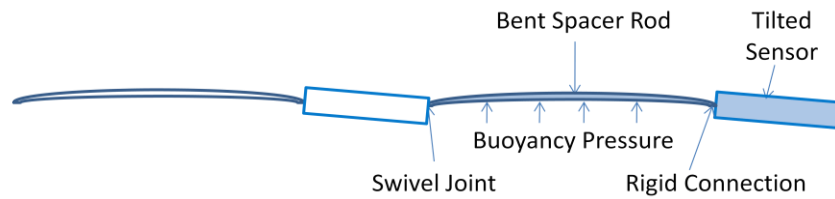
Figure 9. Instrument tilt caused not by ground movement, but buoyant bending of spacer rod. No actual ground displacement occurred.

These headaches might be avoided in future horizontal IPI installations by preventing or neutralizing the effects of water in the casing. The borehole should be drilled with no slope or slight uphill slope, in order to allow any infiltrating water to drain out the open end. Alternatively, small holes may be drilled in each spacer rod before installation, in order to allow water in and out of them when the rest of the casing and instrument is submerged or drained. In our installation, each casing joint was sealed with primer, PVC glue and electrical tape. However, it is unrealistic to expect such a

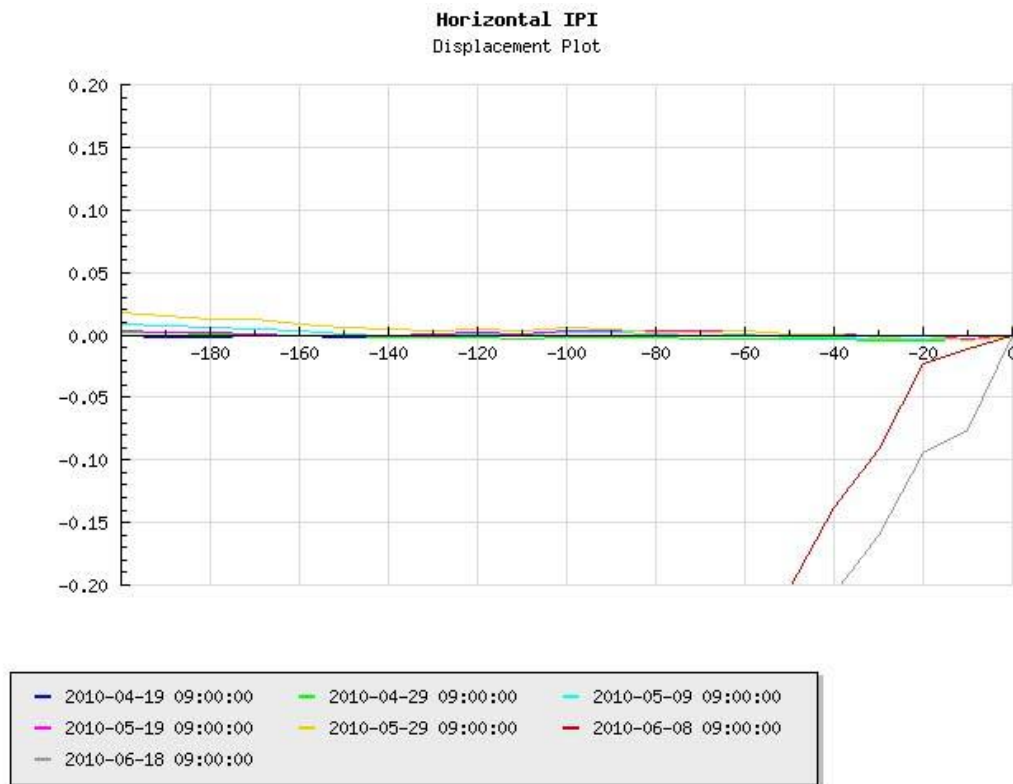
After the casing had filled entirely with water, a new baseline was established under the new, buoyant condition, and the movement thresholds reset. Alas, when the TBM excavation did reach the area of interest beneath the instrument, the surrounding rock was drained of groundwater, and the water within the casing was rapidly drained along with it. The buoyancy force was removed, and the spacer rods and sensor elements returned to their original orientation, once again triggering the appearance of movement where none had occurred (Figure 10). Finally, after the TBM had passed, the excavation was lined and waterproofed, allowing the groundwater to return to its original level and the instrument to fill with water. The cycle of wet-dry-wet was repeated when the second TBM drove through.

Figure 10. Output of automated online system (ARGUS), showing sudden displacement between 5/29/10 and 6/8/10, well beyond the magnitude of anticipated ground movement. The displacement was not real, but rather caused by draining the casing of water, which released the buoyant pressure bending the spacer rods.
