2012.09.05.6 IJKDIJK AIO-SVT GEOTECHNICAL ANALYSIS

2012.09.05.6 IJkdijk All-in-one Sensor Validation Test - Geotechnical Analysis

Stichting Flood Control

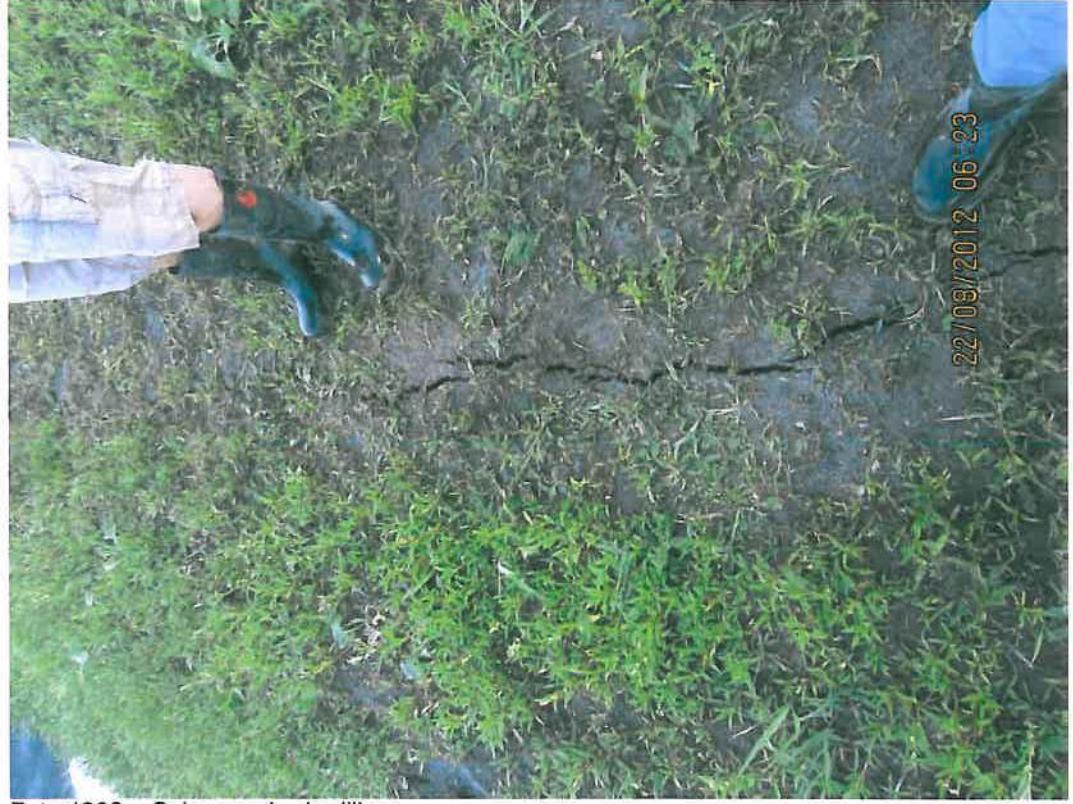
Foto 1292 – Scheuren in de dijk.

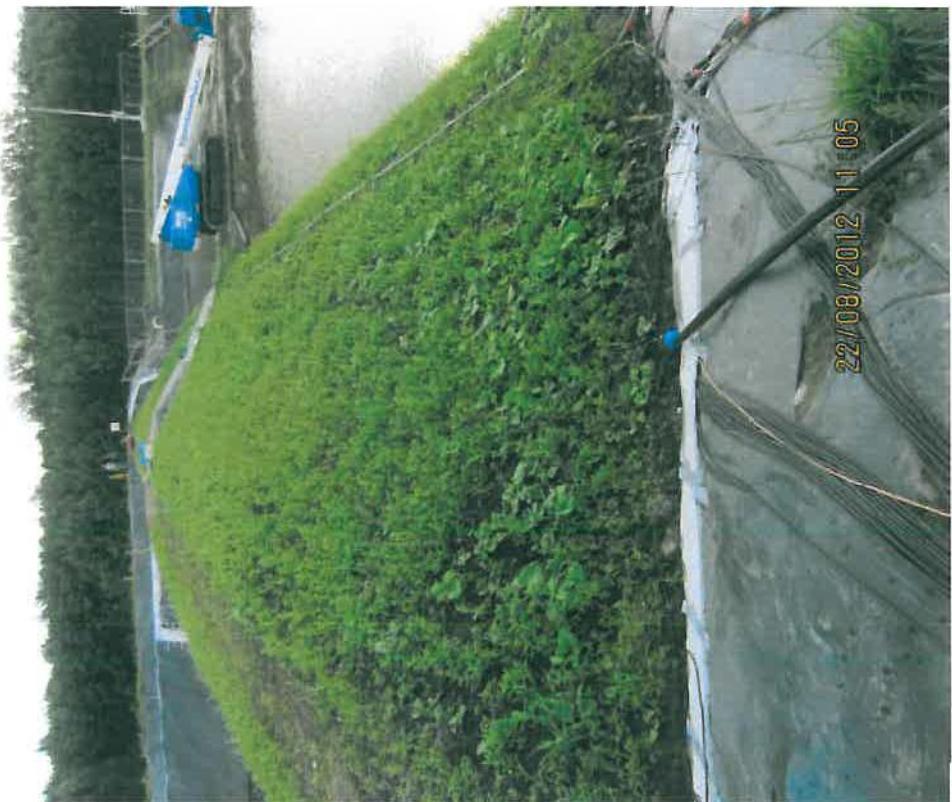
Foto 1306 - Overzichtfoto van het talud.

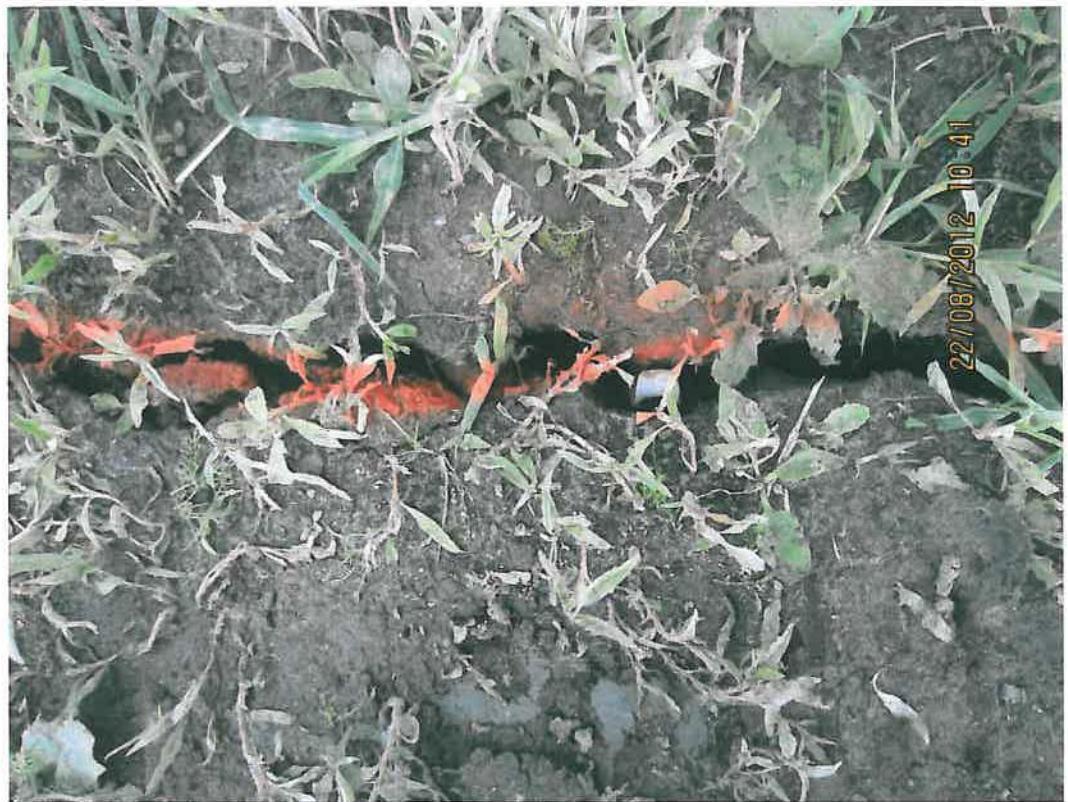
Foto 1303 – Scheuren in de dijk ingespoten met oranje verf.

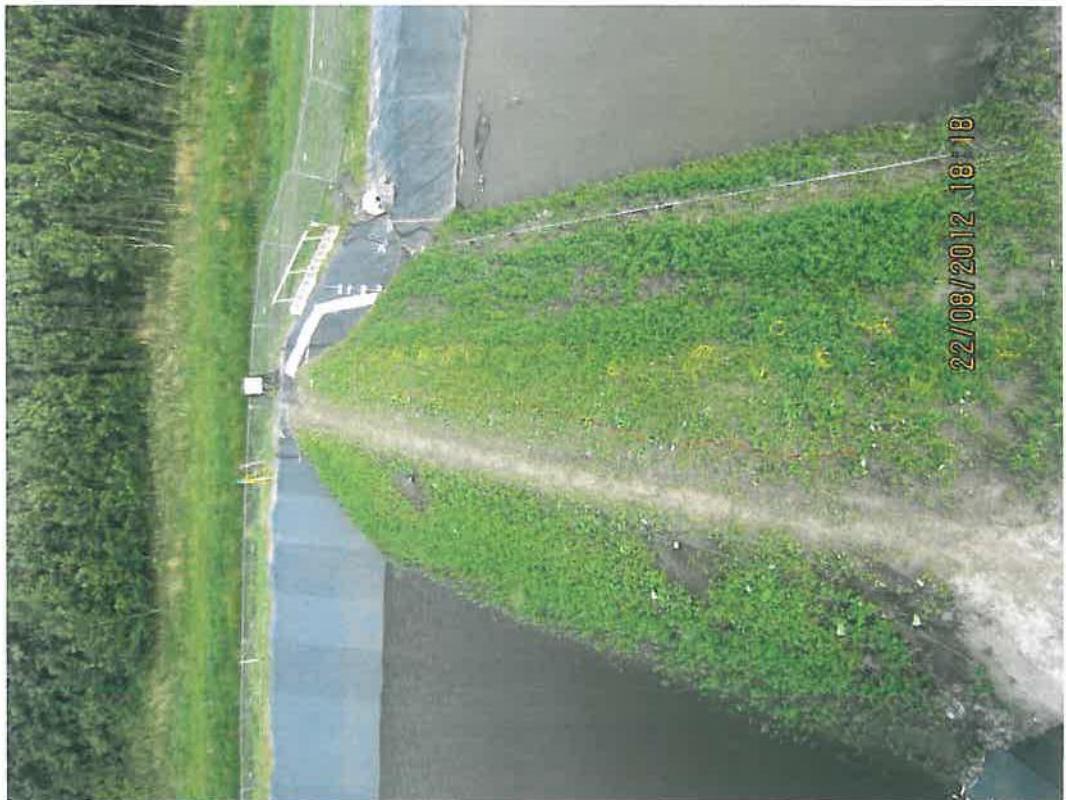
Foto 1318 – Overzichtsfoto scheuren in de dijk.

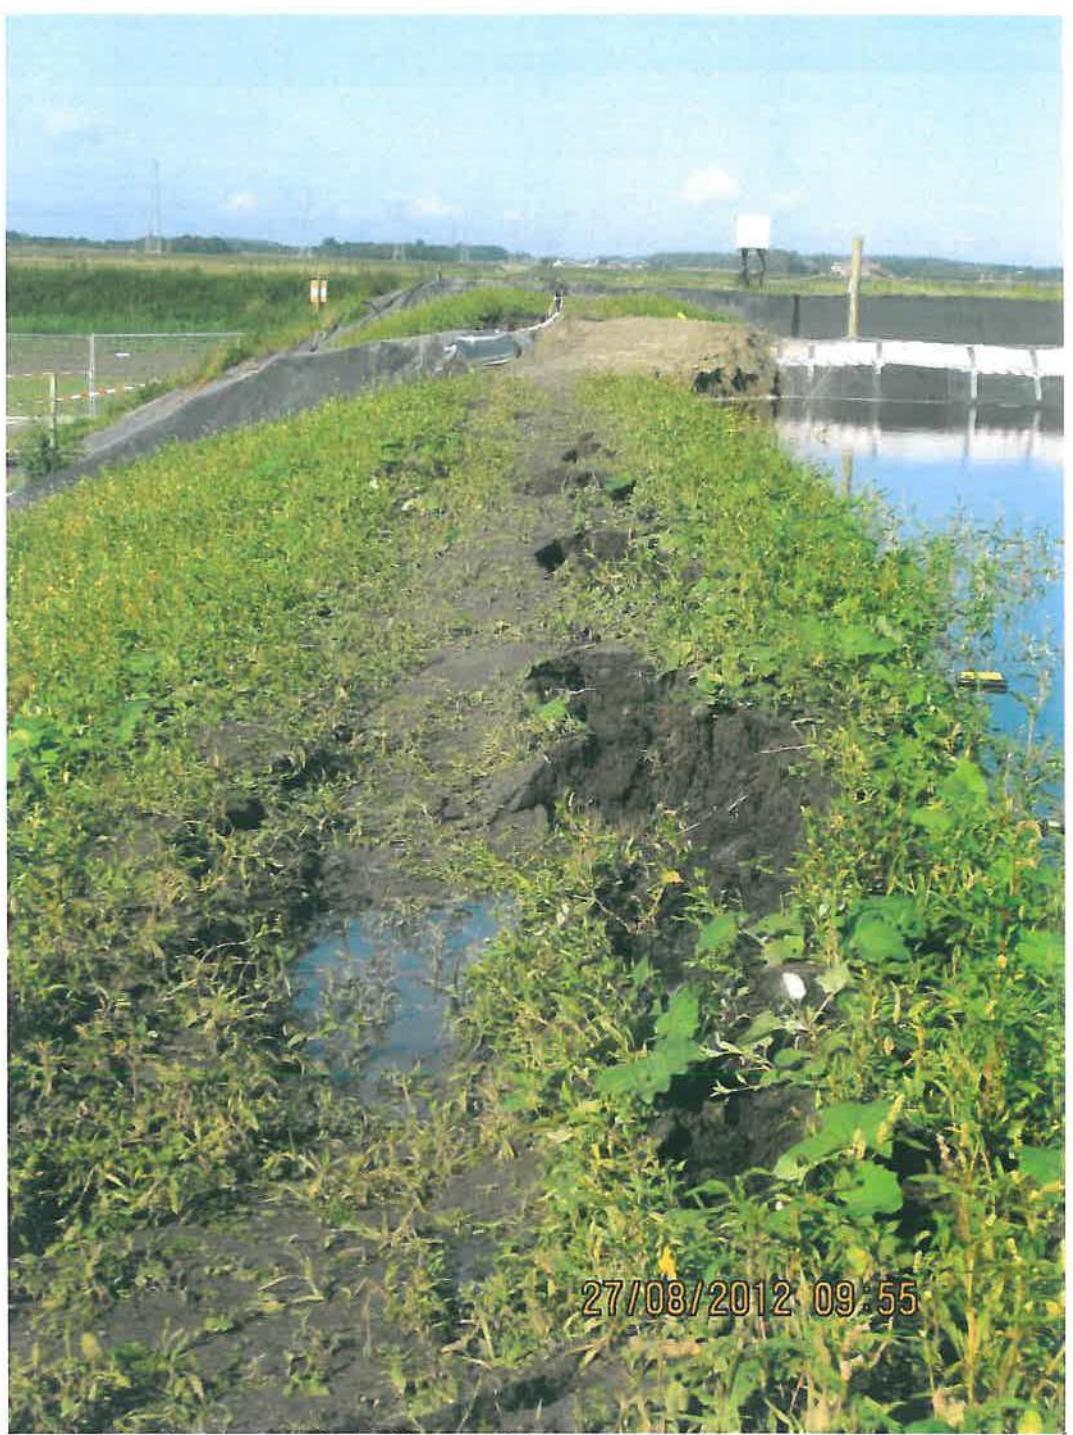
Foto 1591 - Close-up verzakking. Water vult de scheuren.

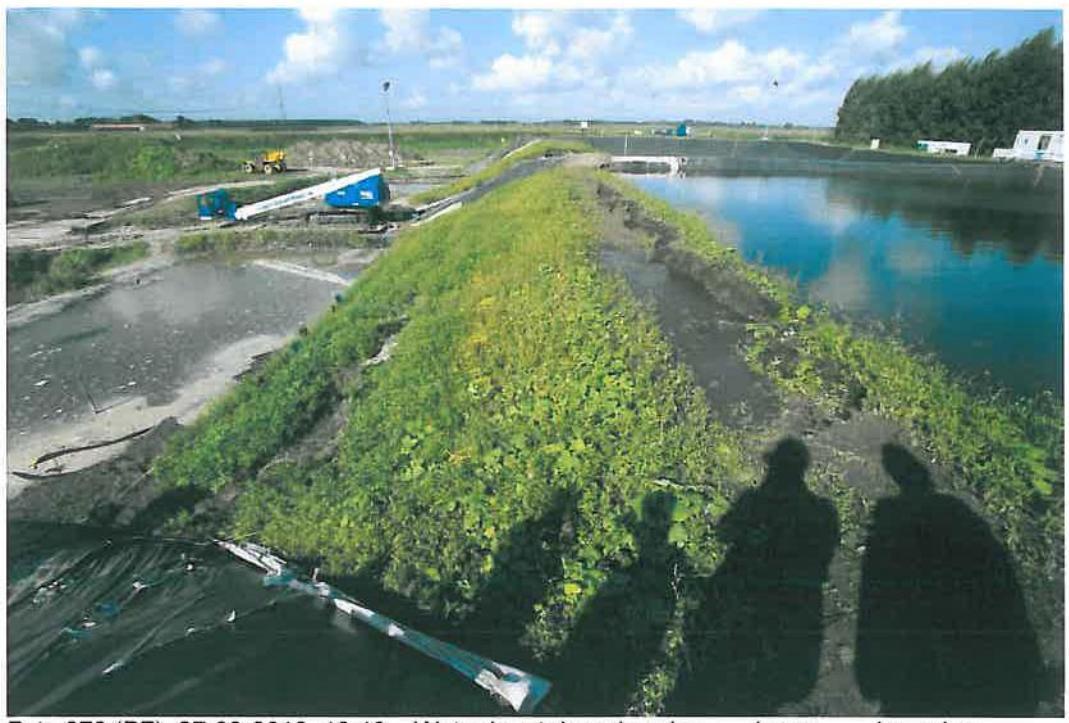
Foto 070 (PF) 27-08-2012 10:18 - Water loopt door de scheuren heen naar beneden.

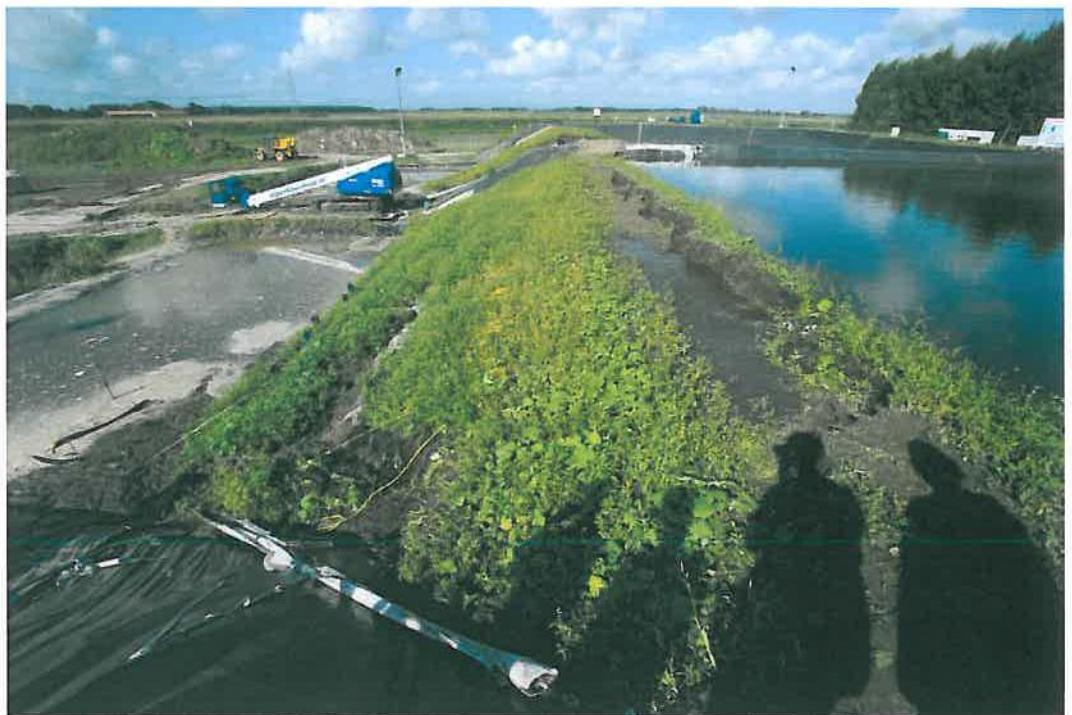
Foto 071 (PF) 27-08-2012 10:19 - Water spoelt de toplaag aan de onderkant van de dijk weg.

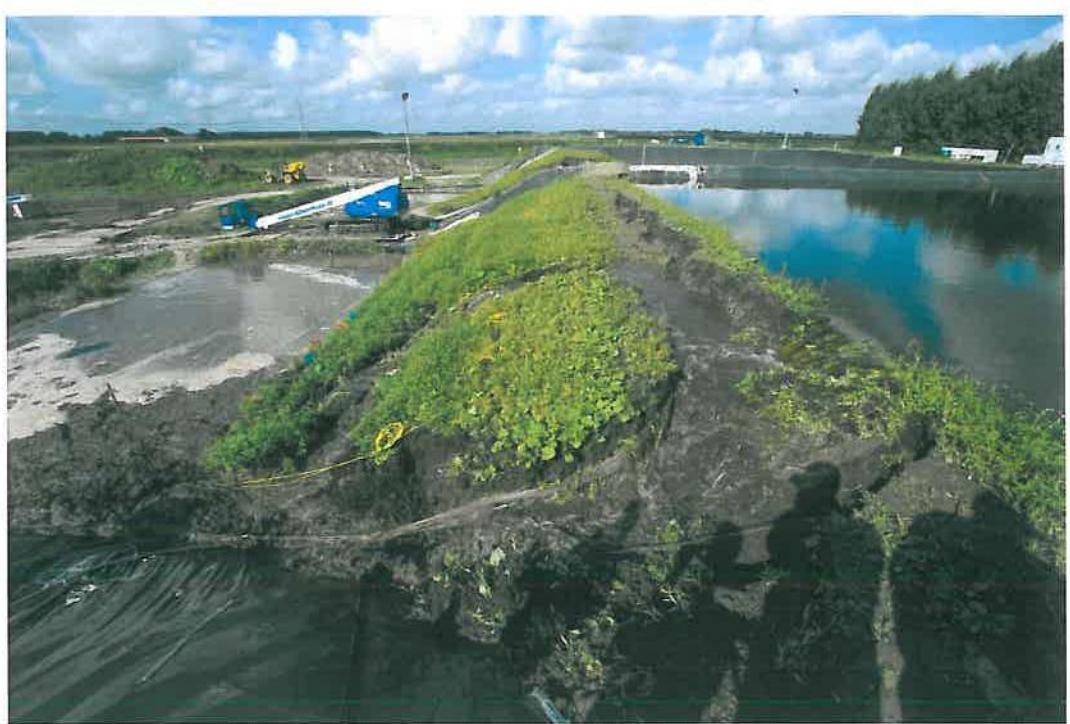
Foto 078 (PF) 27-08-2012 10:24 – Water spoelt door 2 grote scheuren heen en spoelt de toplaag weg.

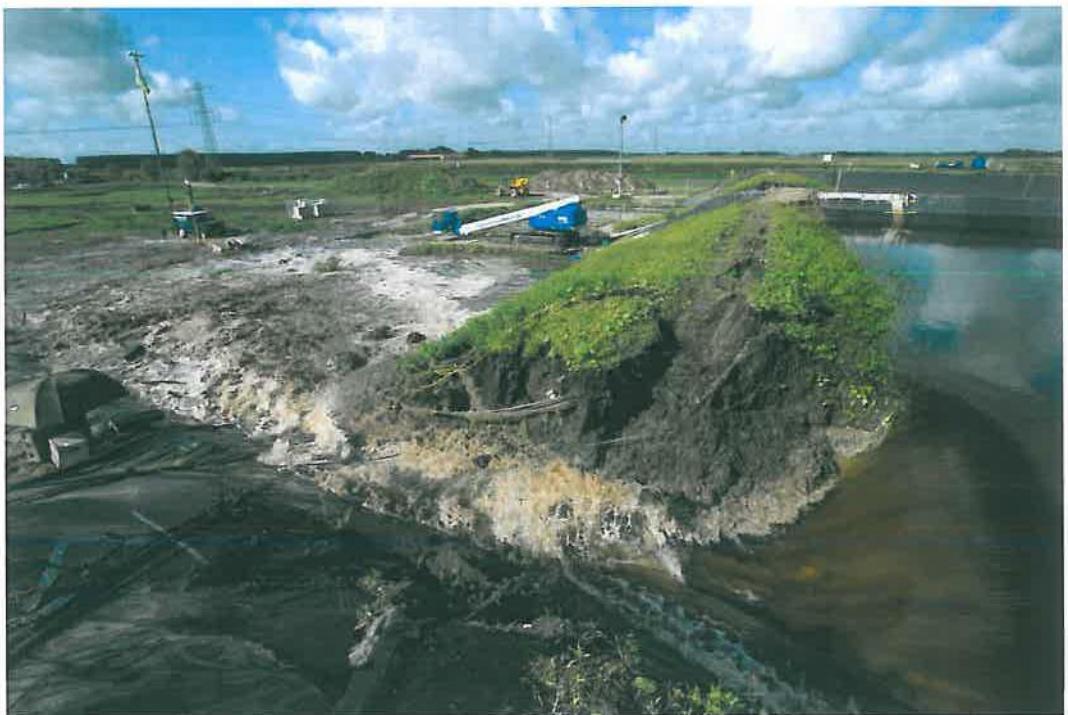
Foto 091 (PF) 27-08-2012 10:28 - Water spoelt de dijk weg.

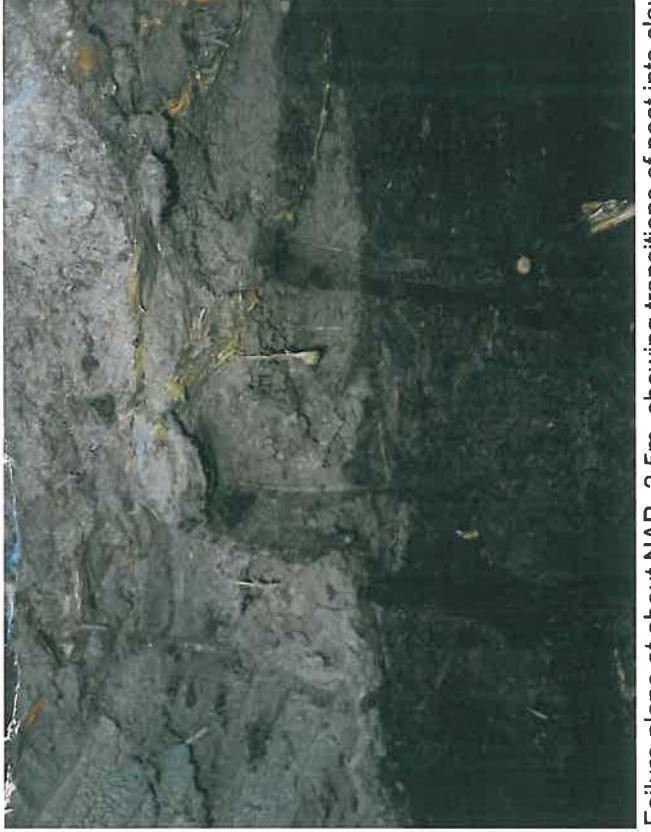
Failure plane at about NAP -2.5m, showing transitions of peat into clay layer

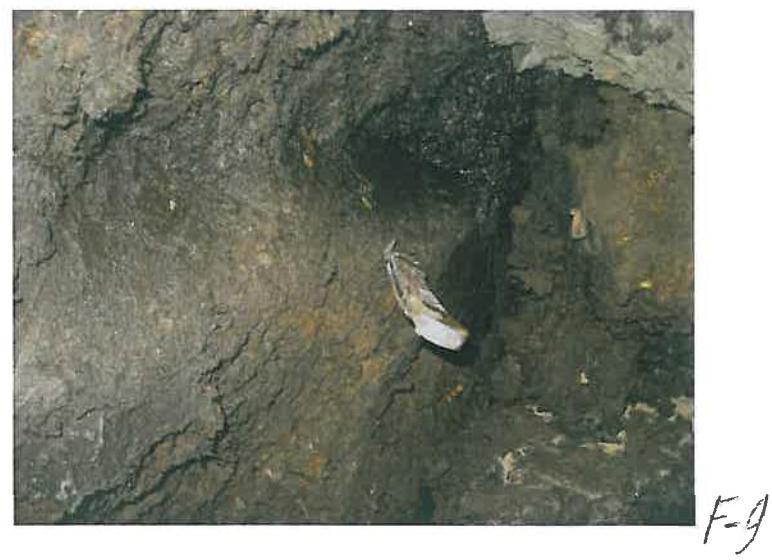
Peat layer around NAP -4m with many weak zones through normally coherent parts, indicating fracturing

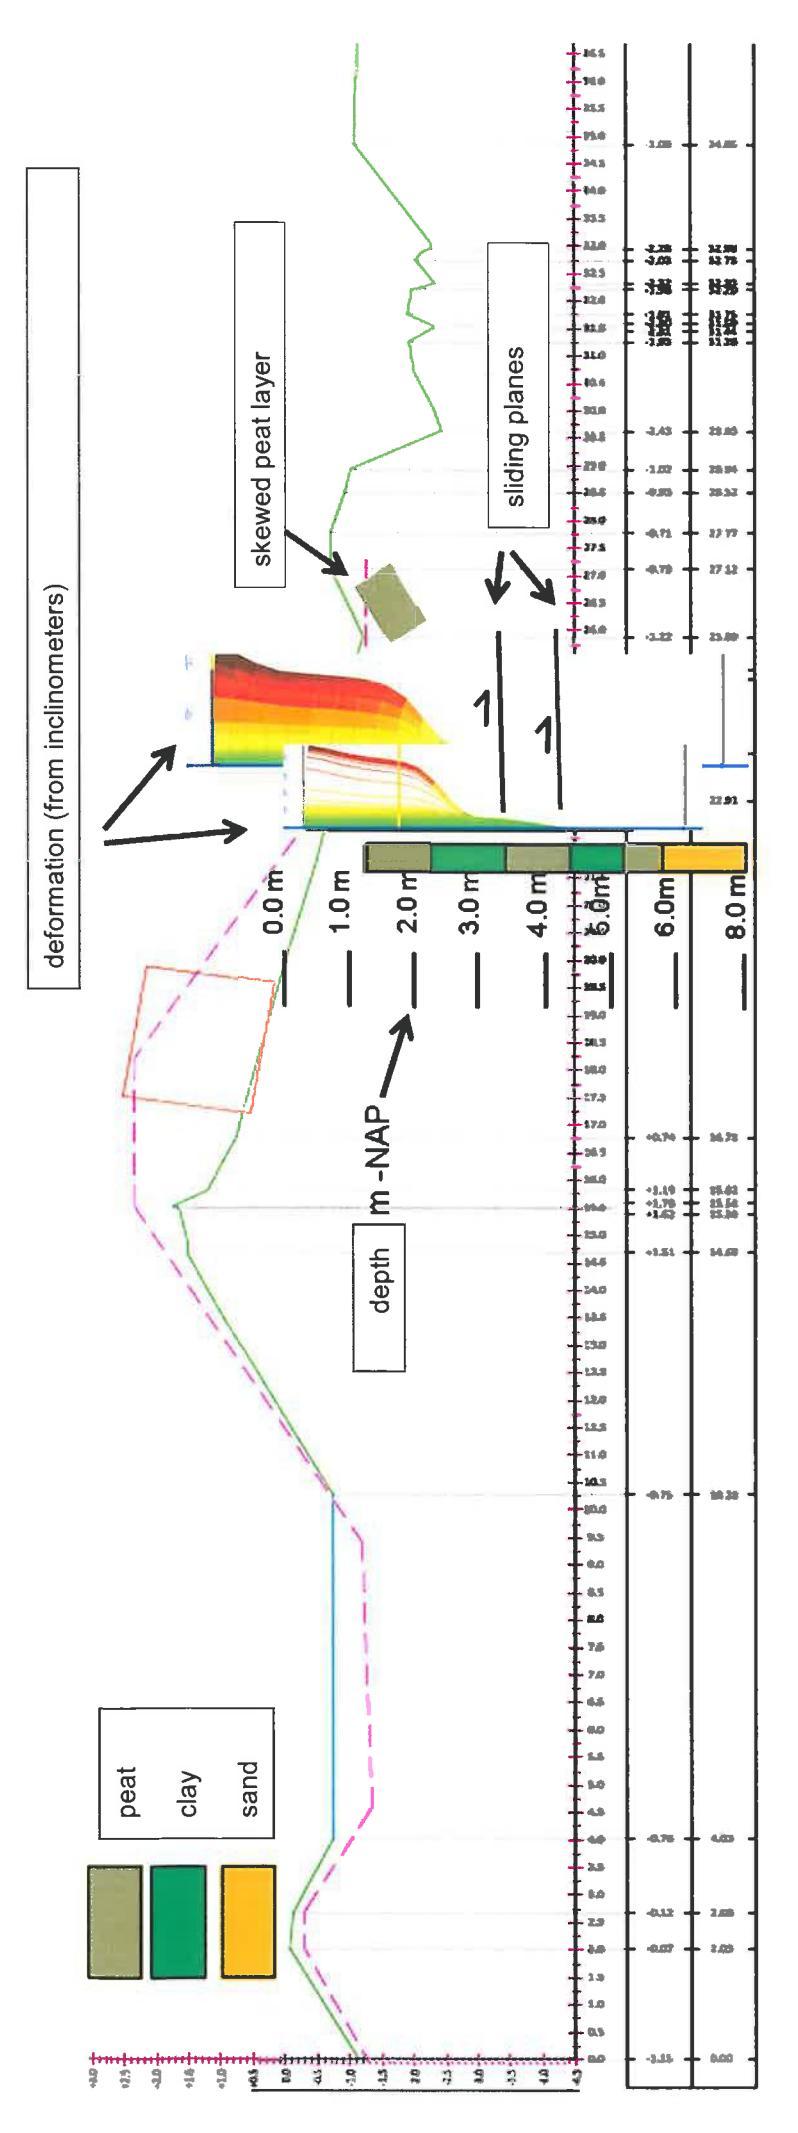
A forensic investigation was carried out two days after the failure. Several trenches were cut in the area where most of the deformation had taken place. Pictures taken at different depths are shown in Appendix 6, page F-9. In Appendix 6, page F-10, a cross-section is shown indicating several shear planes as found in this investigation, as well as the location of a skewed peat layer closer to the surface, which presumably got there only after the slope of the ditch broke into pieces. Inflow of water and failure of the sides prevented detailed analysis at greater depth.

Indication of failure after forensic investigation
