# Full-scale field validation of innovative dike monitoring systems

Koelewijn A.R., Vries (de) G.  
*Deltares*

**ABSTRACT:** Three large scale field tests on dikes have been carried out at the IJkdijk test site in the Netherlands. Two tests involved piping, micro-instability of the sand core and erosion from overtopping. Both dikes failed on micro-instability. The third test involved slope stability with a deep sliding plane. All tests were done to validate monitoring systems and dike safety information systems. Several systems performed well.

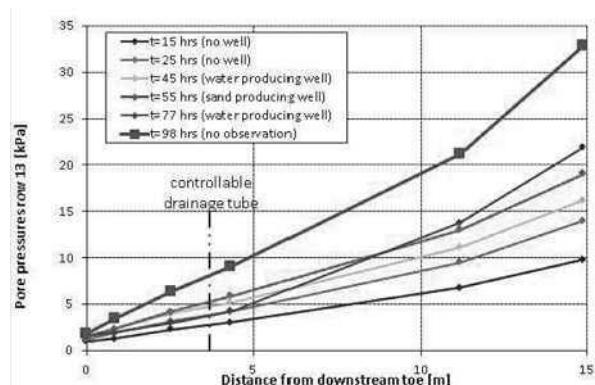
Figure 3. Pore pressures at sand/clay interface West

At 66.7 hours after the start of the test ( $t=66.7$ hrs), at a head drop of 2.02m, the lower drainage tube was partly opened as piping had already been detected at the third line of pore pressure meters, i.e. upstream of this tube. This had a clear effect on the pore pressures, as shown in Figure 3, and the piping process stopped.

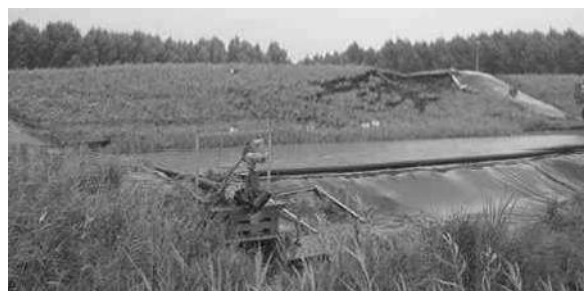
Figure 4. West dike close before failure.

At  $t=110.1$  hrs, considerable sliding of the downstream slope had occurred. Piping had resumed too, but the continued sliding from micro-instability of the sand core caused so much settlement of the crest that at  $t=111.9$  hrs (August 26<sup>th</sup> at 8:24 am) failure occurred.

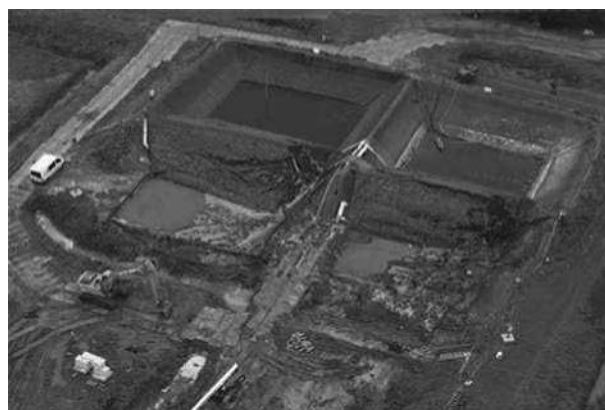
Figure 5. West and East dikes after failure.

As the last stages of the hydraulic load were delayed in comparison with the West dike, severe settlements from micro-instability of the sand core occurred later. Here at  $t=138.9$  hrs (August 27<sup>th</sup> at 10:18 am) failure from micro-instability occurred. Figure 5 shows an overview of both failures.

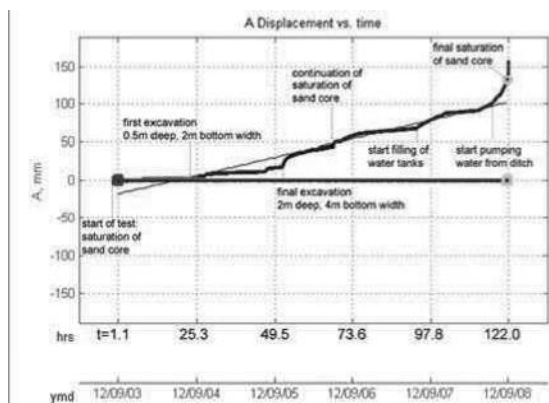
Figure 6. Horizontal displacements at toe of dike until close to failure.

by infiltration of water into the sand core. The next day, a small excavation was made in front of the dike. This had a limited effect on the dike, as shown in Figure 6 by the horizontal displacements at the toe of the dike. The next day, a final excavation was made and on the basis of slope stability calculations it was decided to continue by hydraulic loading only. In order to acquire a lot of measurement data, several days were taken to raise the phreatic surface in the sand core and to fill the water tanks on top. Finally, failure occurred on September 8<sup>th</sup>, at 2:27 pm, after 122.26 hours, see Figure 7.

Table 1 shows the results of slope stability calculations at characteristic moments applying the models of Bishop (1955) and Van (2001). The latter is a geometrically more flexible variant to Bishop's model. The results correspond well to the deformation behaviour shown in Figure 6: close to the critical value of 1, the deformations quickly increase. These results may even draw some suspicion, but it should be borne in mind that quite advanced soil investigations had been carried out prior to the test (Zwanenburg et al. 2011, Koelewijn and Bennett 2012) and detailed actual measurements of pore pressures were available. Moreover, the model by Bishop has already long ago been described as surprisingly accurate for conditions close to failure (Spencer 1967).
