Buoyancy Effect on Slightly Sloped Horizontal In-Place Inclinator

Charles George; Niels Jensen, P.E., PhD

GZA GeoEnvironmental, Inc.

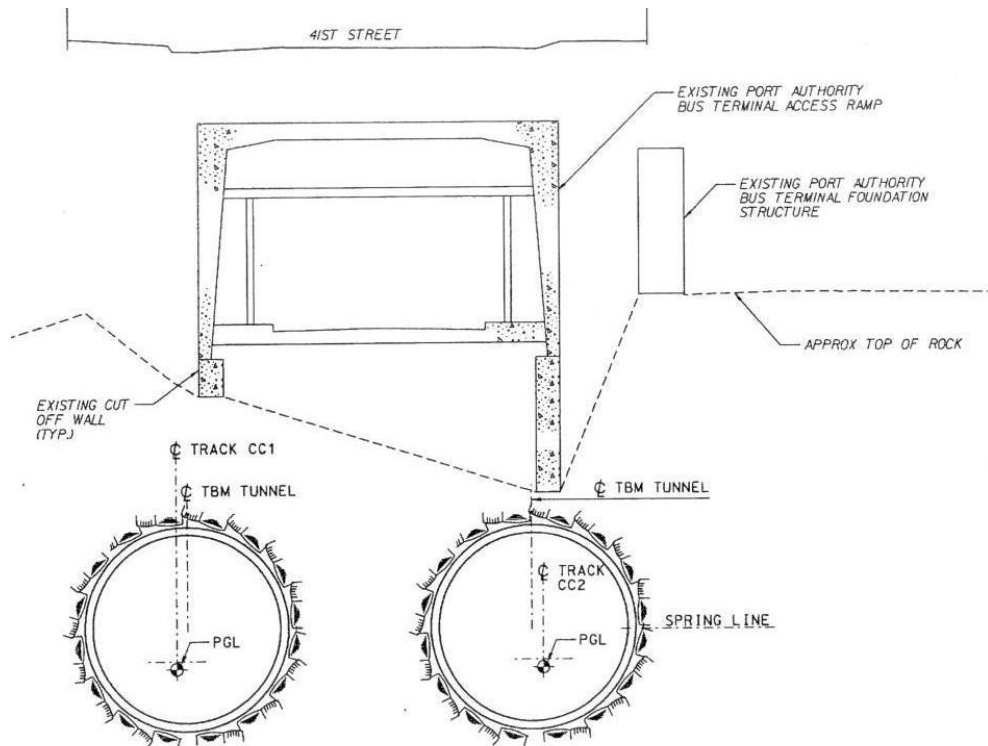
The TBM's were to hole through to a receiving chamber excavated beneath the basement of the Port Authority Bus Terminal (PABT), the busiest bus terminal in the world by traffic volume. Due to the proximity of tunnel excavation to the foundations of the PABT – in some cases, within 5 feet (Figure 1) – the instrumentation specification included 10 vertical borehole extensometers (BX) to monitor ground movement during the TBM drive 200 to 500 feet from the receiving chamber.

Figure 1. Cross section of final tunnel drive beneath PABT foundations.

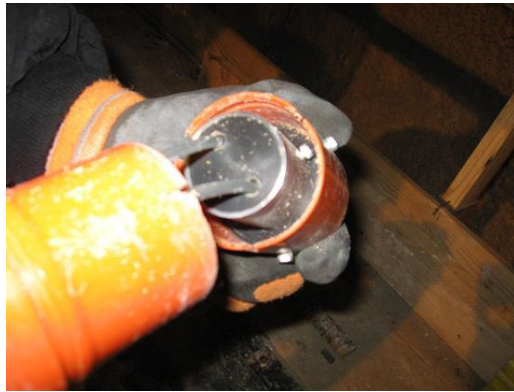
The Geokon inclinometer casing was installed in the borehole with a length of cable inside attached to a pulley fixed to the end-cap (Figure 5). The instrument itself (also made by Geokon) was attached to the cable and inserted into the casing by simultaneously pushing the instrument and pulling it in with the other end of the cable. The difficulty of installing the casing was increased by having the wire cable strung through it. However, the wire and pulley system proved necessary, given the difficulty of inserting the instrument to a depth of 200 feet, horizontally.

Figure 5. IPI casing end cap with pulley and cable attached.

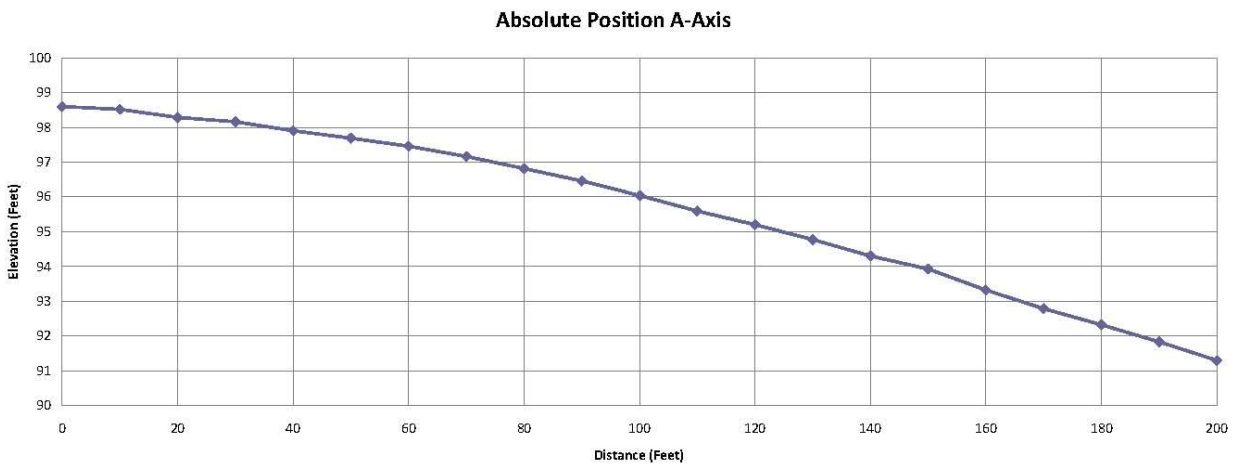
Baseline readings were obtained for each sensor's A-axis orientation (Figure 7).

Figure 7. Baseline position shown in absolute elevation. The instrument is designed to detect displacement from the baseline configuration.
