Chapter 24

Multiple Flow Slide Experiment in the Westerschelde Estuary, The Netherlands

Abstract Flow slides form a major threat to flood defences along coastlines and riverbanks in the Netherlands. Due to the uncertainties with respect to the process in combination with the severity of the consequences and costs for prevention measures, there is a need to improve existing models for prediction or occurrence of, and damage by, flow slides. One of the key questions to be answered is whether slope failure by a flow slide is caused by up-slope migrating breaches or by static liquefaction. Although fundamentally different mechanisms, both result in a flowing sand-water mixture or turbidity current that eventually redeposits on a gentle slope. Over the last decades numerical models have been developed for both mechanisms, based on flume experiments. Upscaling these experiments is complex, as scaling rules are different for the various processes involved. To evaluate the failure mechanism on a natural scale, validate numerical models and test new technology to monitor the occurrence of flow slides, a large, controlled field test was performed.

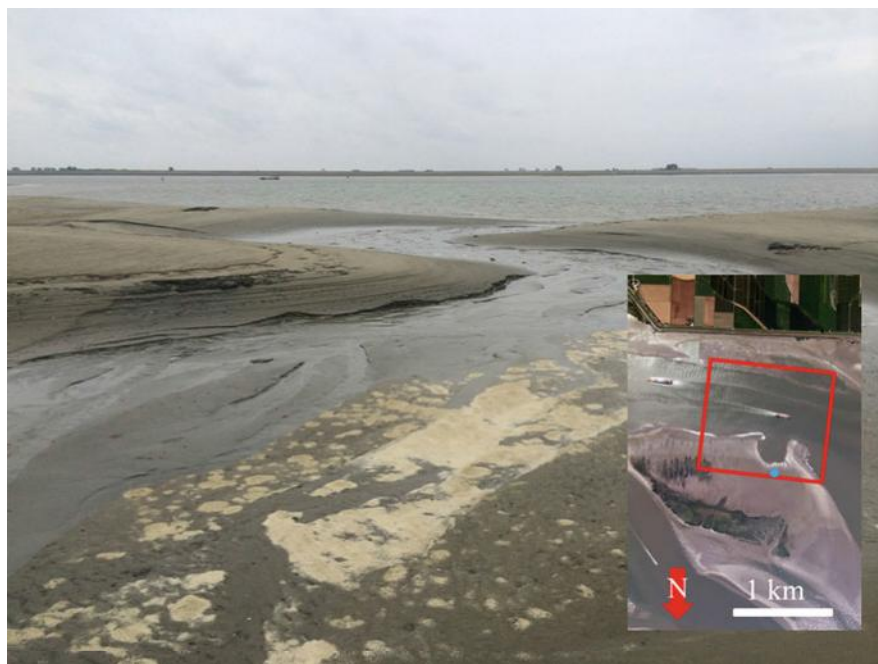
Fig. 24.2 View towards the South from Plaats van Walsoorden sand flat at location of 22nd of July 2014 flow slide. Inset aerial view. Scar of flow slide clearly visible. *Blue dot* is position of photo. Test area indicated by *red square*, see also Figs. 24.1 and 24.3

Most recently a large flow slide (almost 1 Million m³) occurred on 22nd of July 2014 (see Figs. 24.2 and 24.3), exactly at the originally proposed test site. After a week, on 28th of July 2014, further activity was observed on the shoreline, where gullies incised the tidal flat. Vertical slabs of sand were observed to gradually fall into the water. The duration of the event was at least several hours, but probably lasted for over 24 h (Van den Ham et al. 2015). The eroded sand was deposited into the shipping channel, leading to a decrease in the water depth of more than 5 m. As a result, the minimum navigation depth needed to be restored by dredging to the depth required by the Antwerp Port authorities. The bulk of the sand is still present after 6 months and will erode by reworking through tidal currents. The scarp that was created forms a natural bay (see Fig. 24.2) and is being filled in with loosely packed fine sediments. Given the occurrence of this recent failure, the test site was relocated 400 m to the east (see Fig. 24.3), where almost identical pre-failure conditions were found.

It is likely that the flow slide of 22nd of July 2014 started in a similar way, with a small retrogressing breach, but it continued retrogressing for many hours into the subaerial zone of the tidal flat, finally resulting in the observed large amphitheatre shaped bay and depositing the eroded sand in the shipping channel. Seemingly, the turbidity current extended over a much longer distance (over 750 m). It may have been catalysed by the effects of draining of pore water at low tide in combination with flushing of fresh rain water in gullies (see Fig. 24.2), since, unlike our test, this natural flow slide was preceded by heavy rainfall.

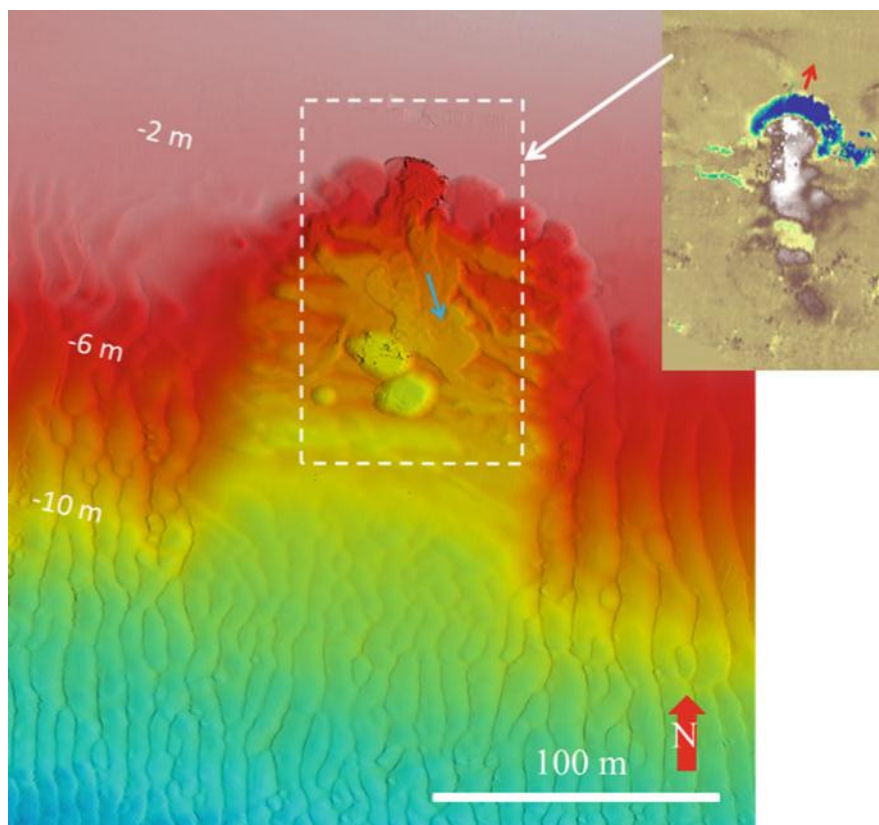
Fig. 24.4 Multibeam detail dredging area (red square in Fig. 24.3) at 1-10-2014-19:30 UTC with active retrogressing breach and turbidity current (see also Fig. 25.5). Inset differential plot with 15' interval (blue = erosion, yellow/white = deposition)

bathymetry map about every 15 min (see Fig. 24.4). Near-real time differential bathymetry plots and cross-sections clearly showed the evolution of the profile (see Fig. 25.5). Since the dredger itself partly blocked the full view on the seabed, the dredged area could be surveyed in detail during the periods that the dredger disposed of the sand in two dedicated areas 300 m up- and downstream of the test site. These dump sites were also surveyed in detail (see Fig. 24.3). Moving sand ripples and dunes could be observed clearly. A third larger vessel served as the test control centre and moved slowly alongside the dredger. This third vessel was equipped with three Acoustic Doppler Current Profilers (ADCP) and three mutually differently oriented 2D imaging multibeam sonars to image the flow slide and monitor the resulting turbidity currents. The pore water pressure meters were registered with a 10 Hz sampling rate during the total test period and could be read on-line on the survey vessel and on a land-based control centre. In this way, the very beginning of the event could be detected. As soon as any flow slide activity

The test took place from 23rd of September until 2nd of October 2014 in generally calm weather conditions. After about 5 days the development of several steep, amphitheatre-shaped breaches started (see Fig. 24.4). These breaches retrogressed
