2012.09.05.6 IJKDIJK AIO-SVT GEOTECHNICAL ANALYSIS

2012.09.05.6 IJkdijk All-in-one Sensor Validation Test - Geotechnical Analysis

Stichting Flood Control

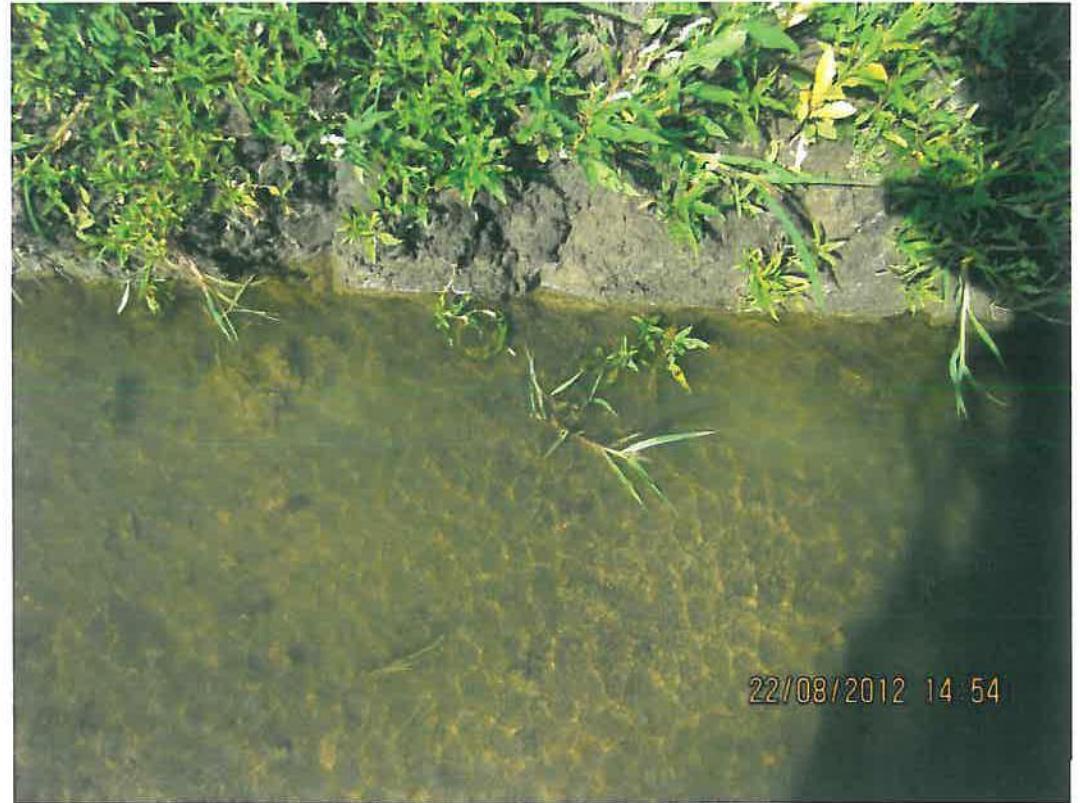
Foto 1308 - Wel 13 en zandwolken.

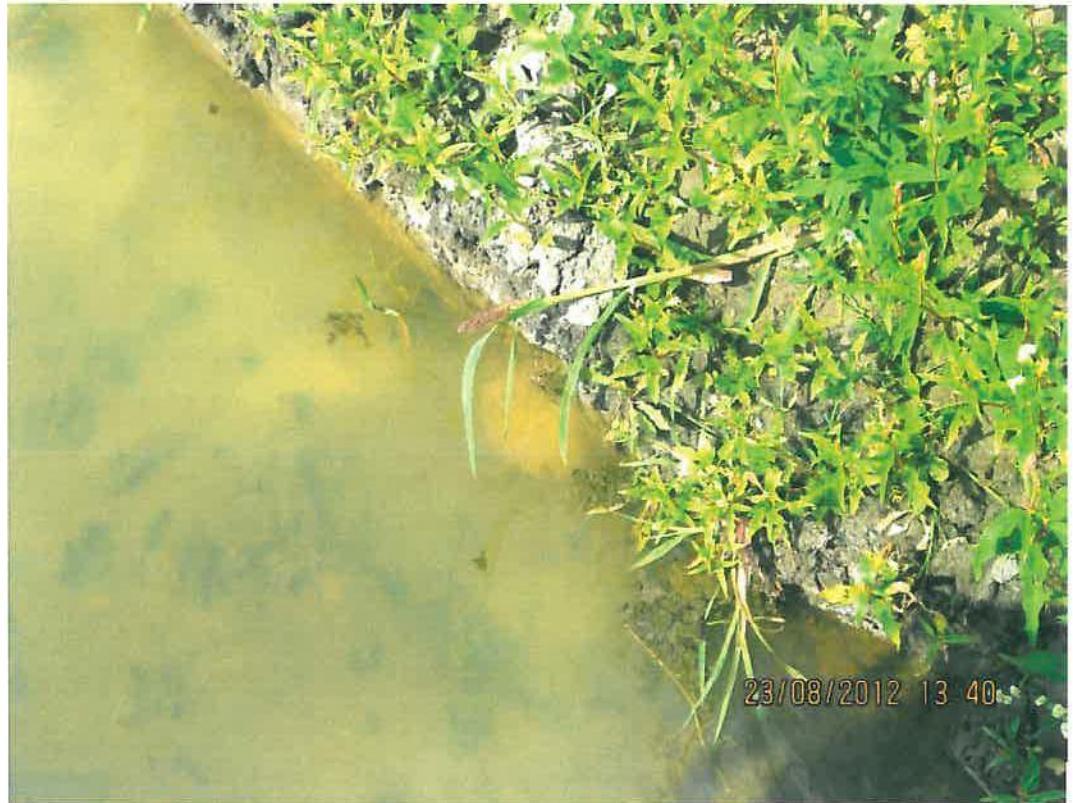
Foto 1337 - Wel 1

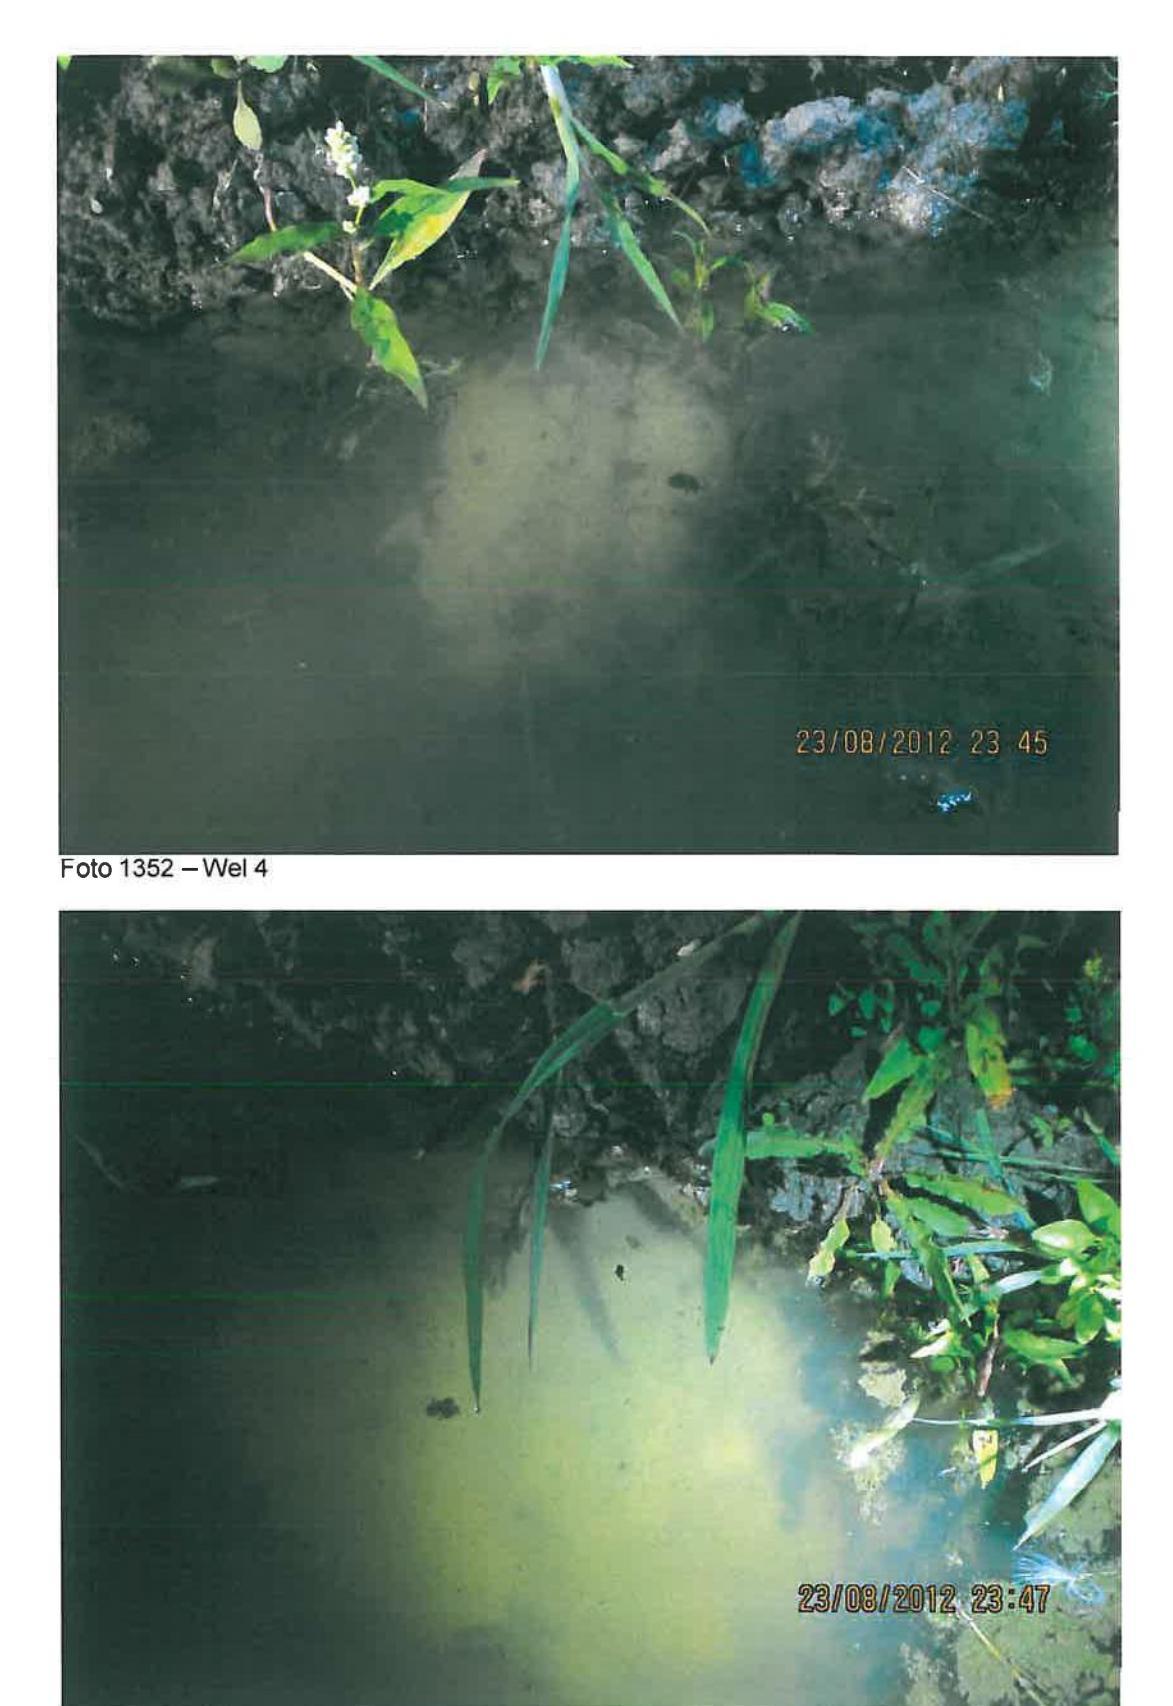
Foto 1353 - Wel 1, zandmeevoerend.

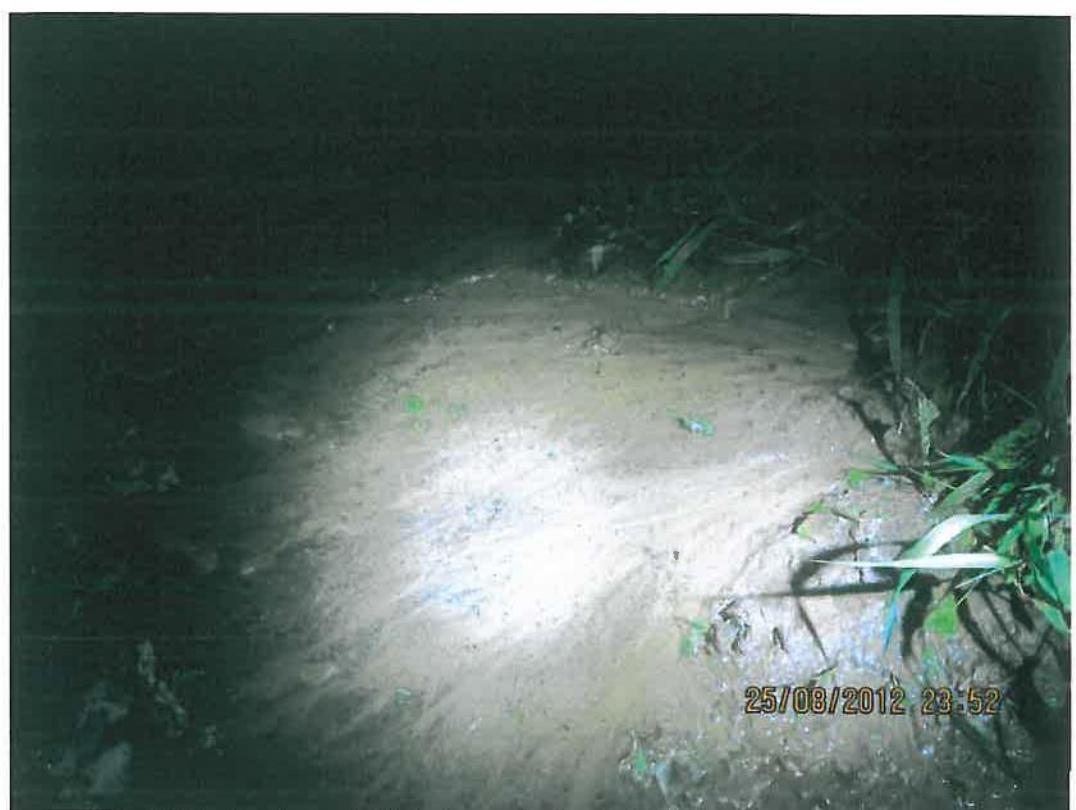
Foto 1469 - Water loopt over het talud en neemt materiaal mee.

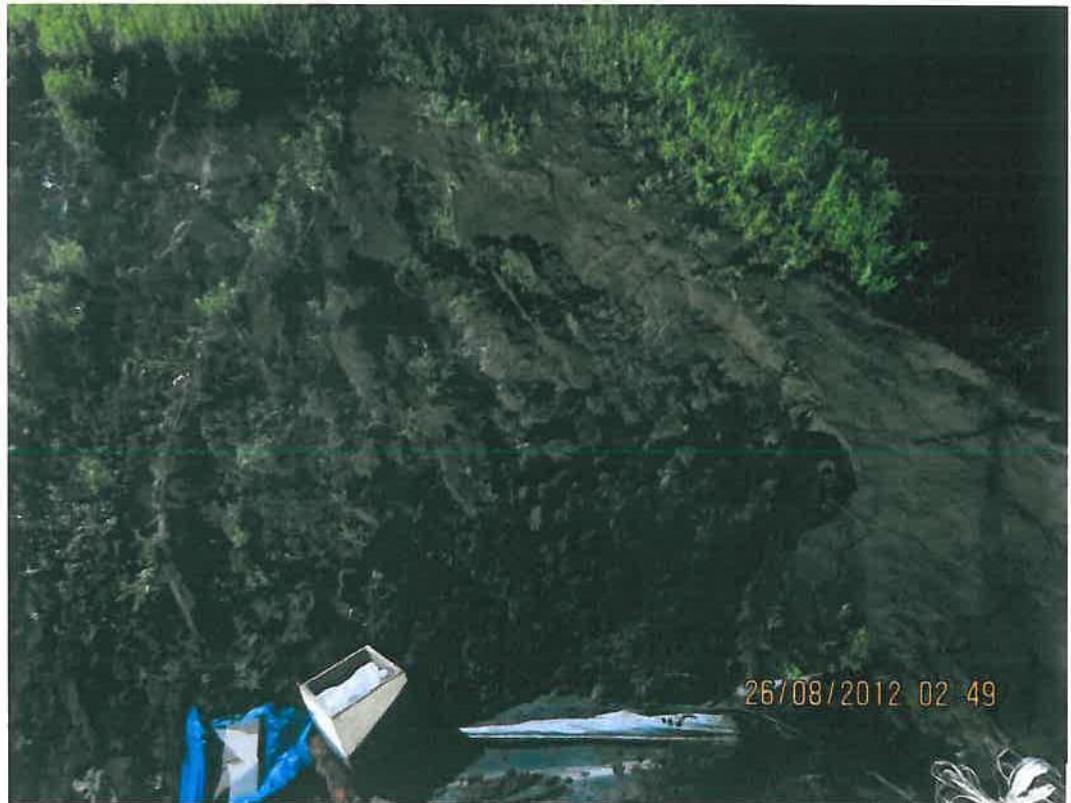
Foto 1472 – Afschuiving aan oostkant van de dijk.

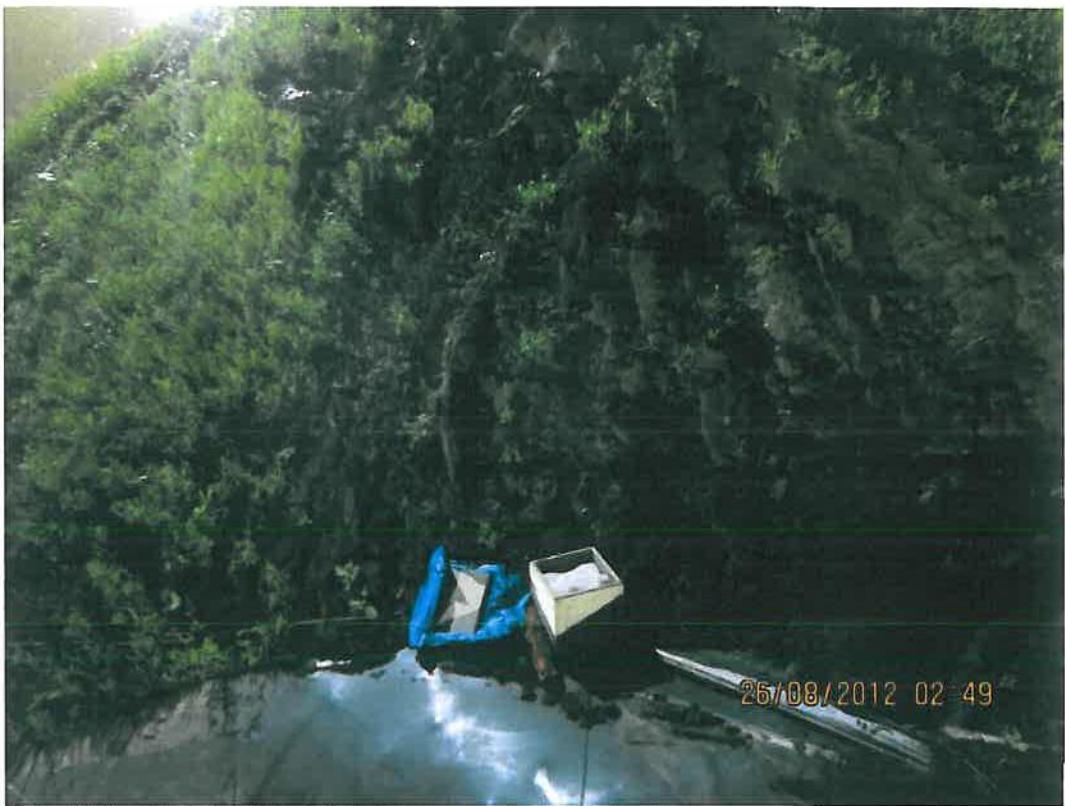
Foto 1473 - Overzichtfoto afschuiving.

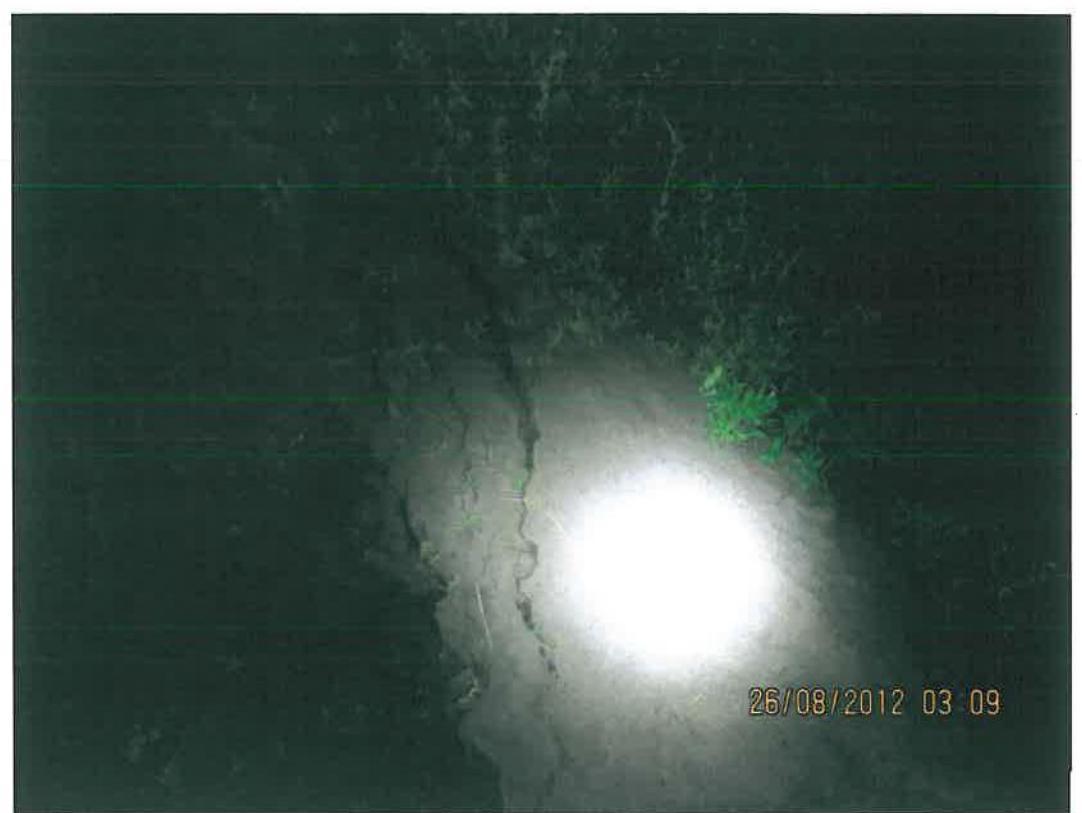
Foto 1477 – Detailfoto bij de afschuiving, deel van de kruin blijft staan.

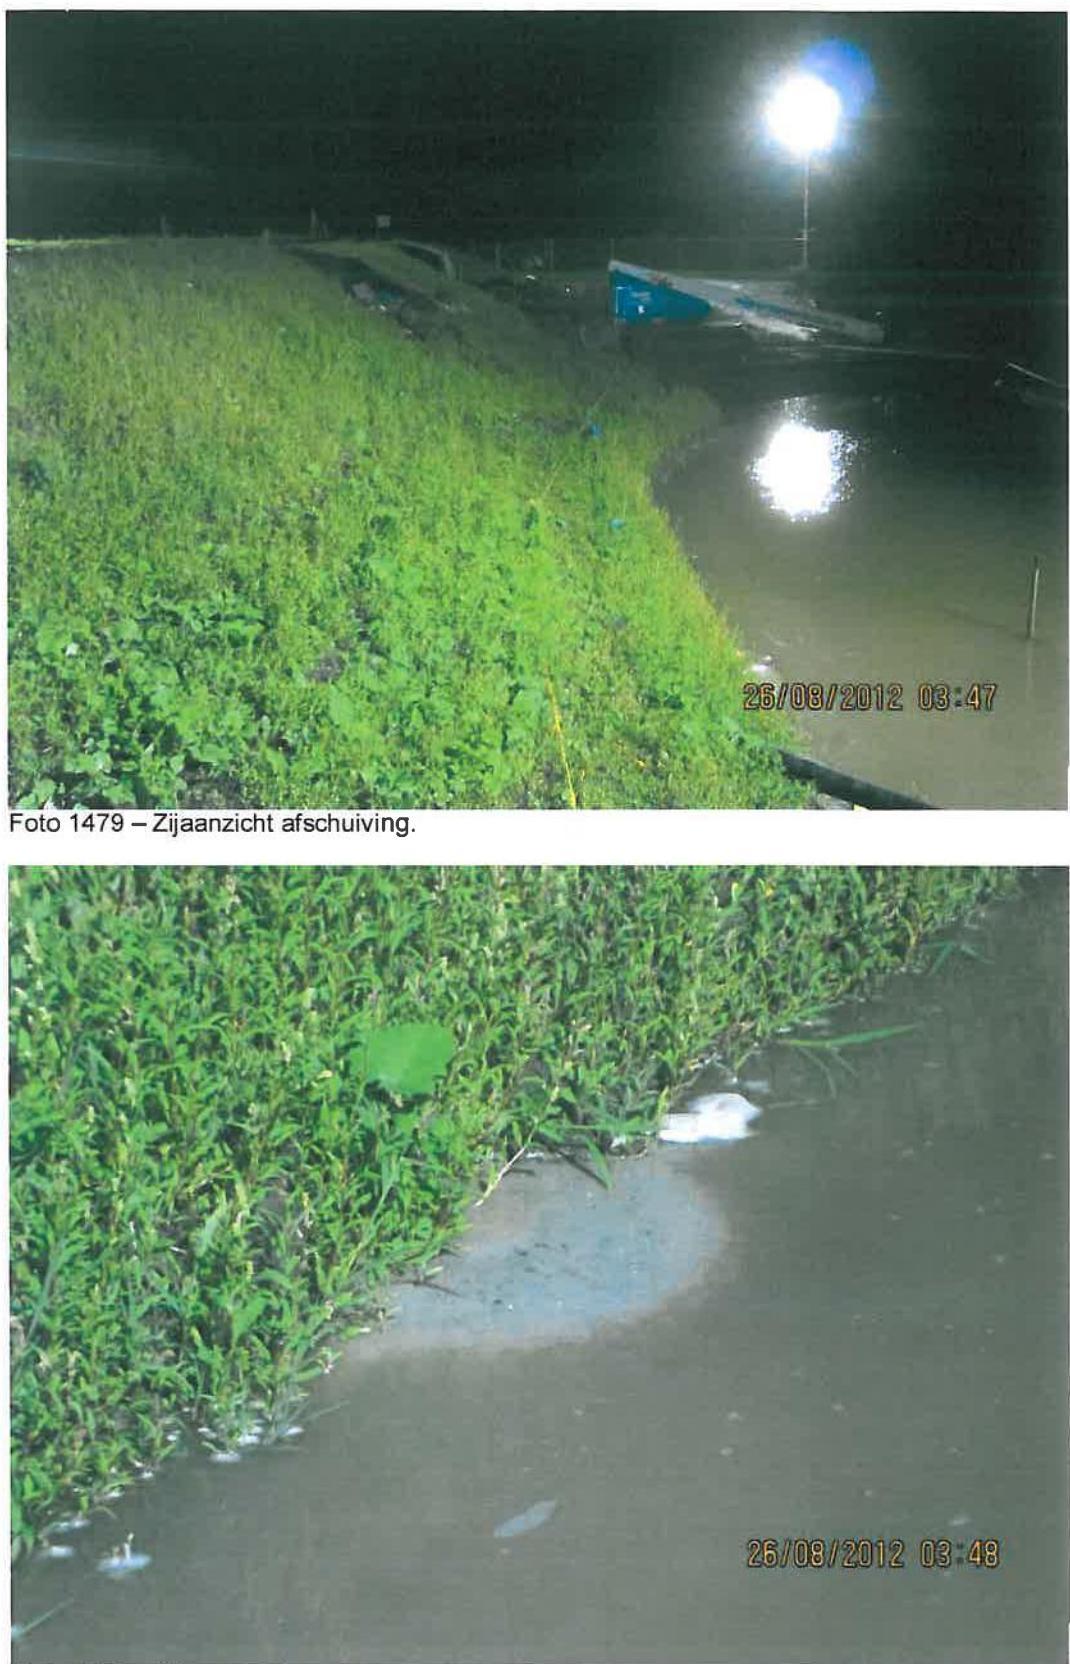
Foto 1480 - Nieuwe wel.

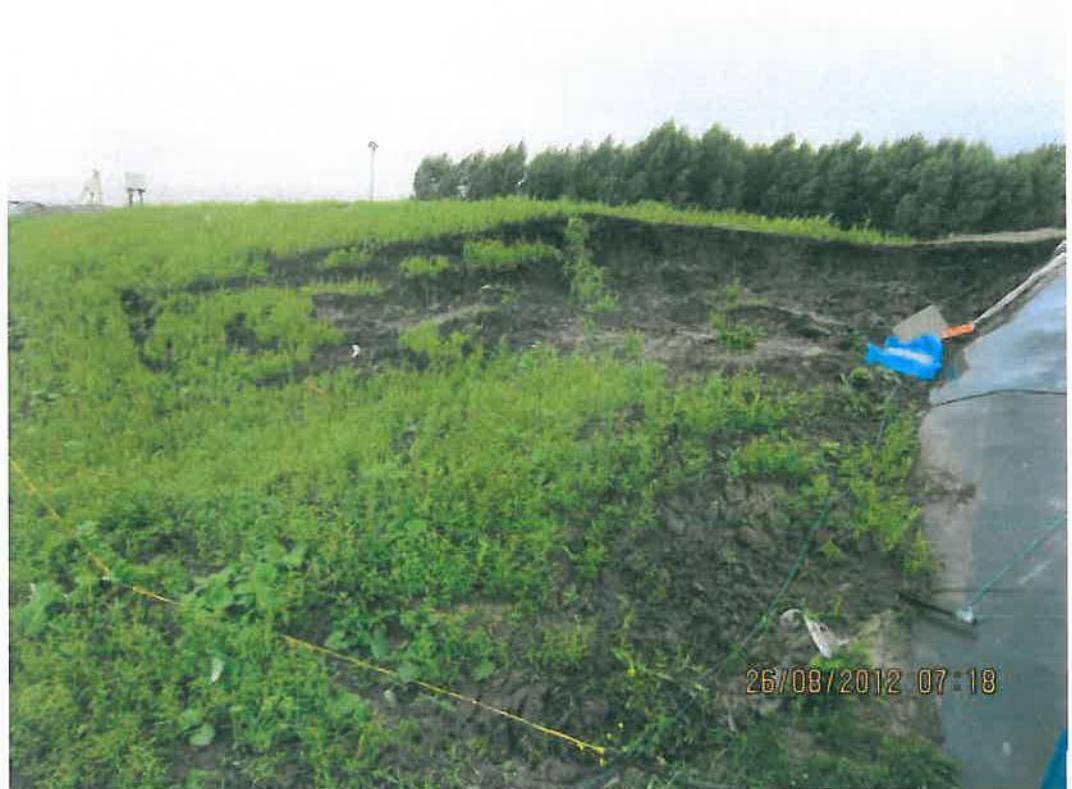
Foto 1484 – Afschuiving zakt verder uit.

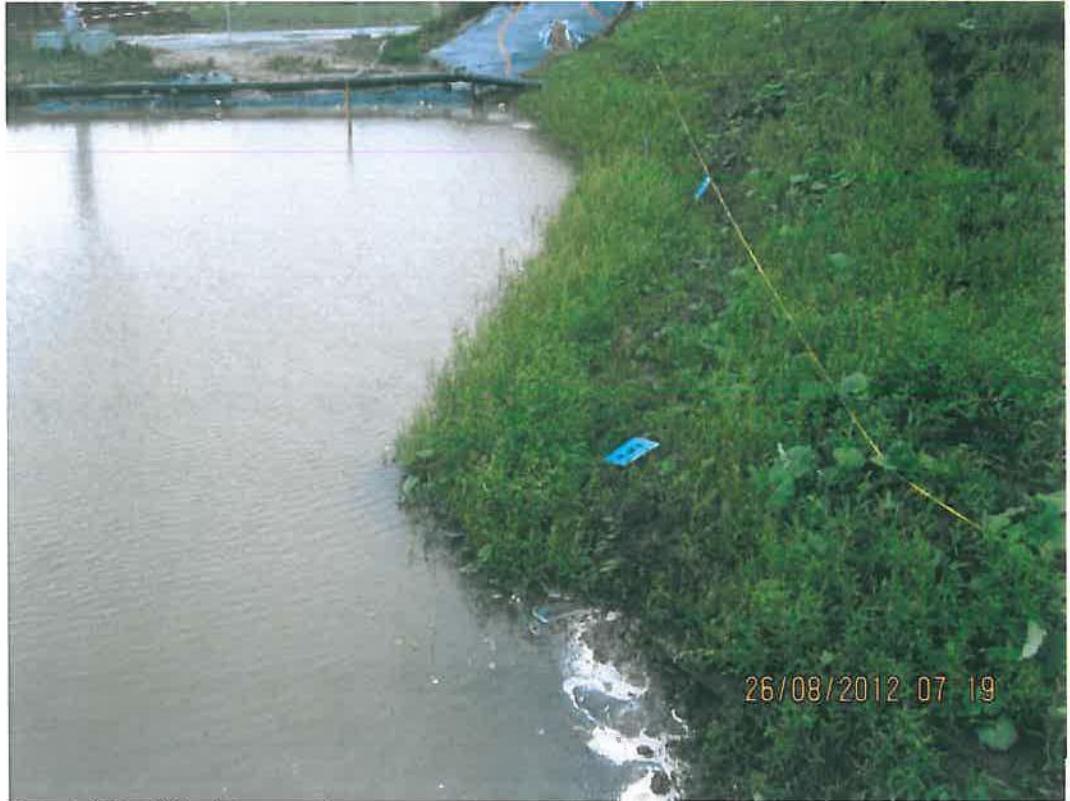
Foto 1487 – Uitbuiking groeit.

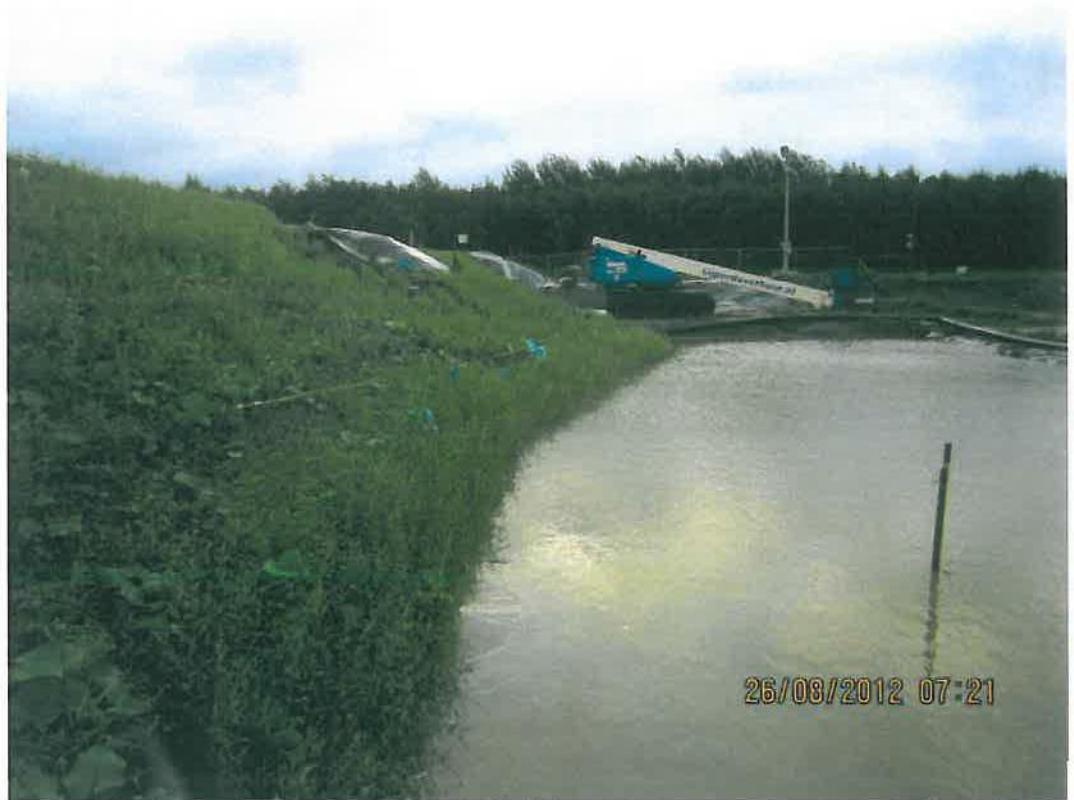
Foto 1488 – Zijaanzicht verschuiving en uitbuiking.

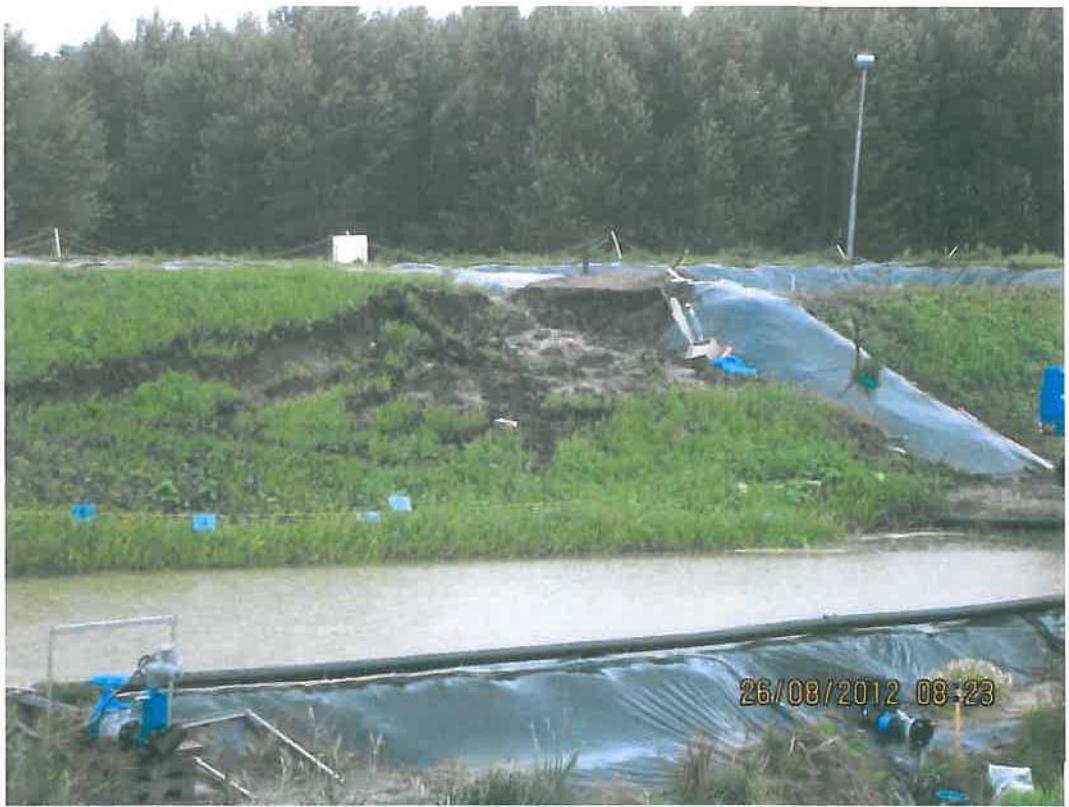
Foto 1491 - Doorbraak.

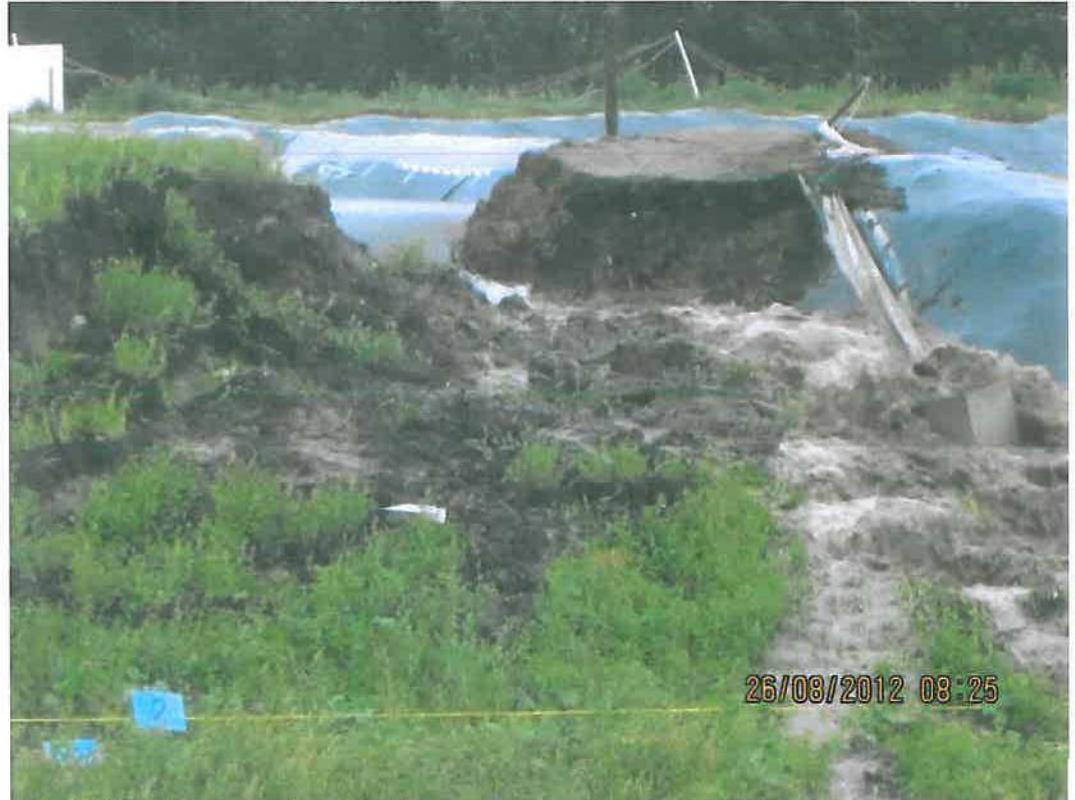
Foto 1499 - Meetapparatuur spoelt mee.

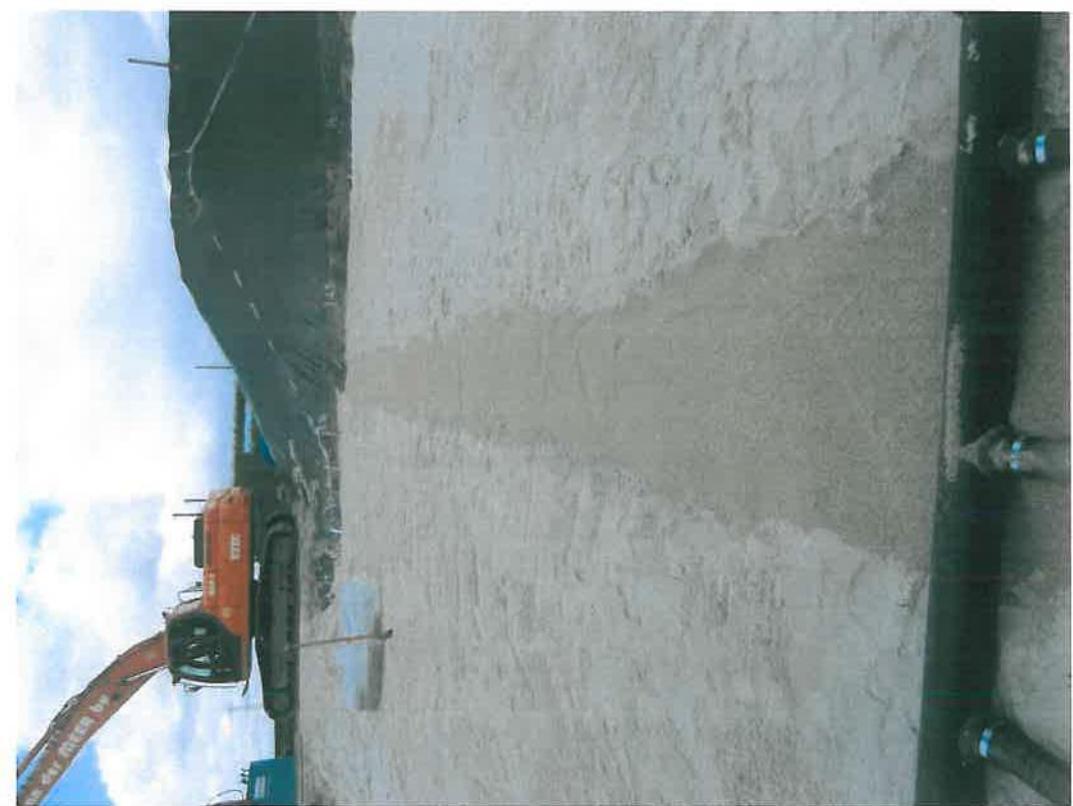
Foto 53 – Overzichtsfoto van de grof-zand-koffer.

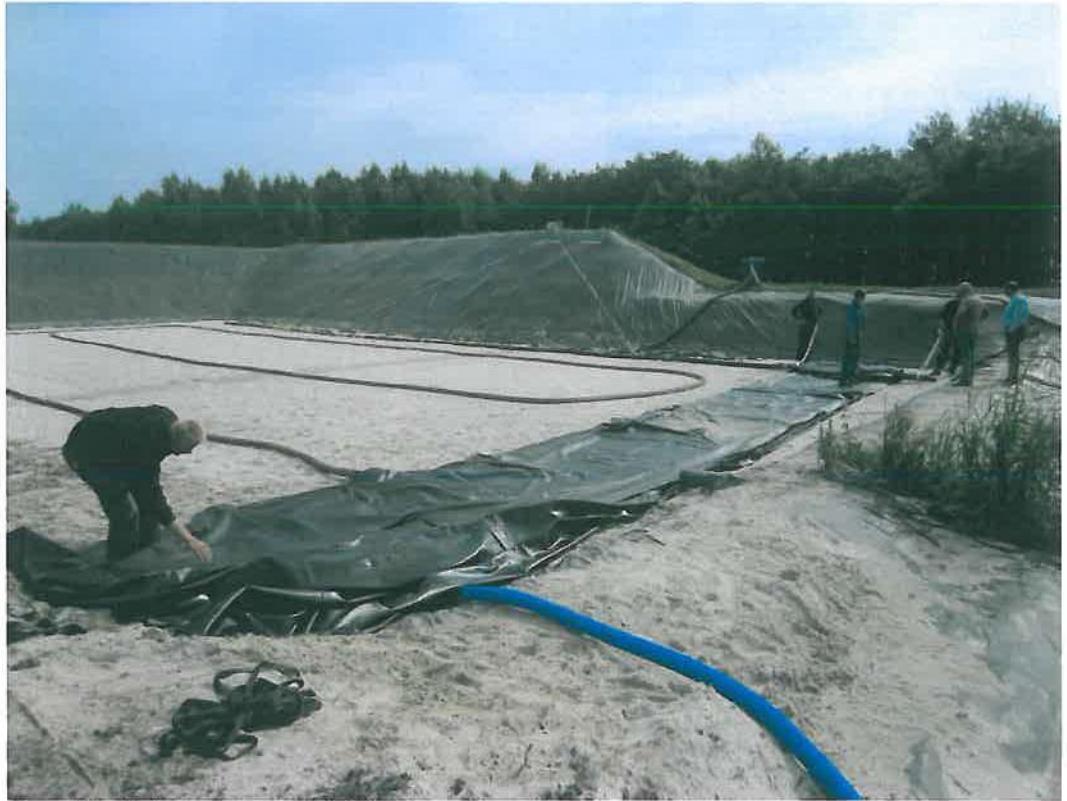
Foto 55 - Het leggen van het folie.

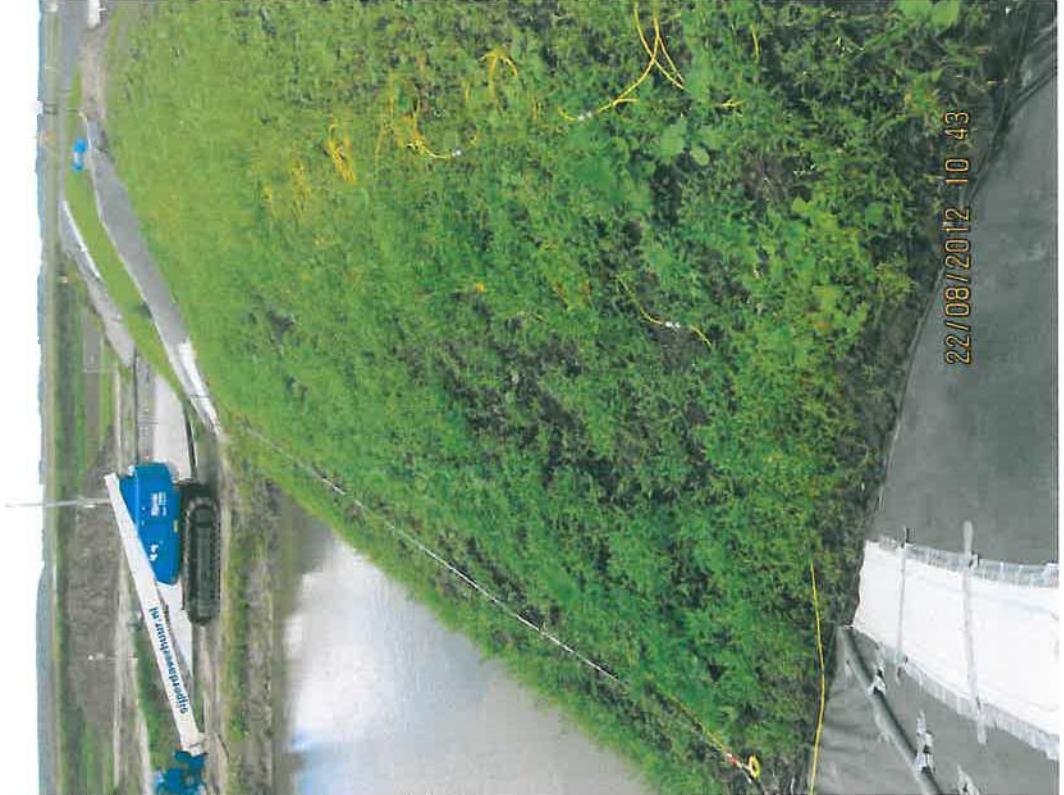
Foto 1305 - Overzichtsfoto van het talud.

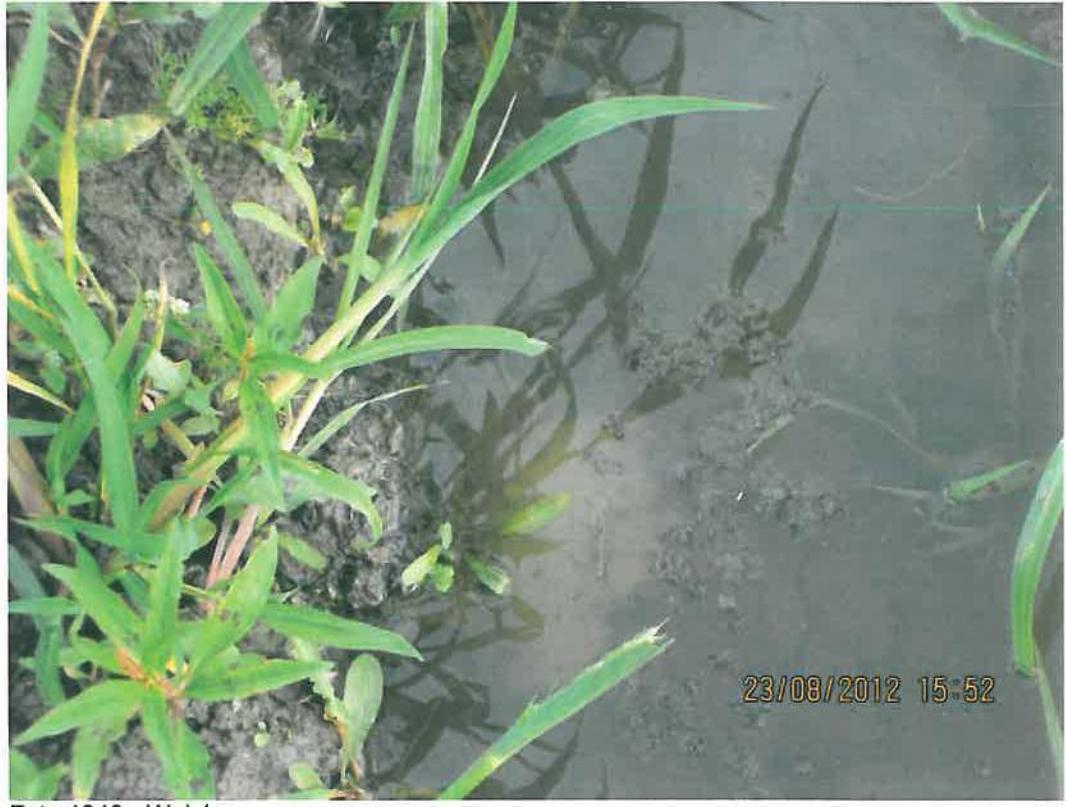
Foto 1340 - Wel 1

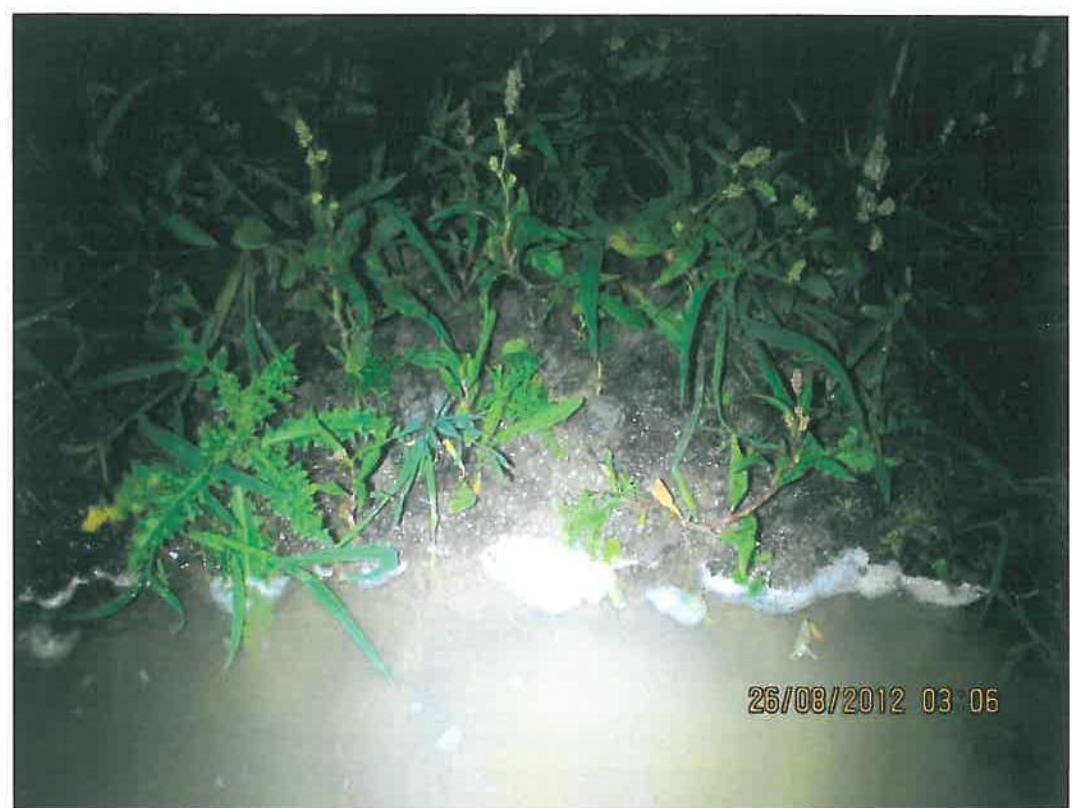
Foto 1475 – Water komt uit het talud, vlak bij de teen.

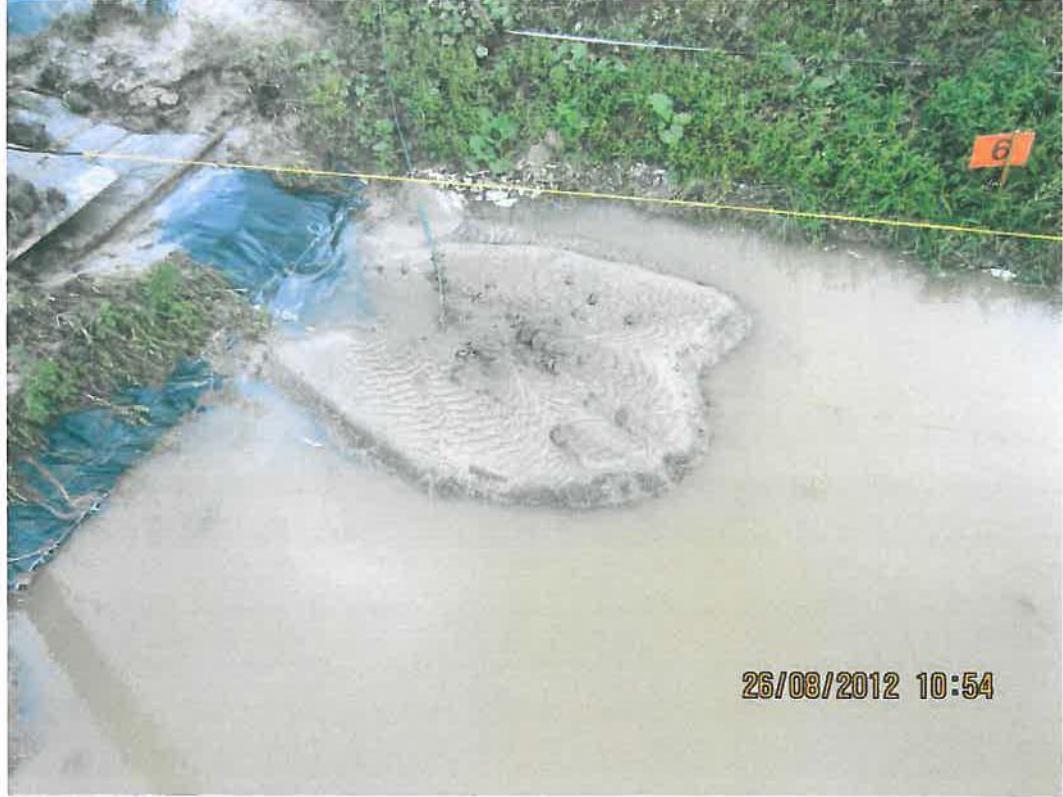
Foto 1542 – Zandplaat ontstaan door overstroming van de westdijk.

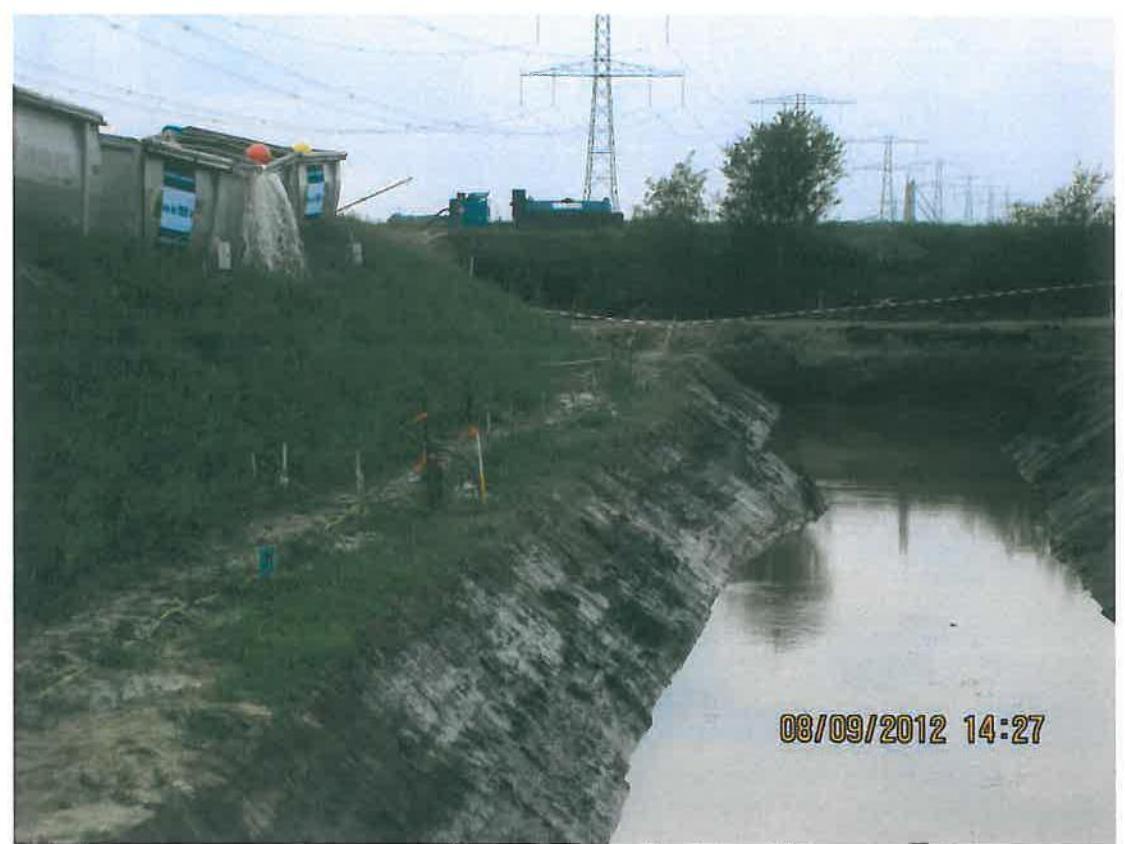
Foto 1873 - Openbarsten en verplaatsen van de slootkant. Inzakking van de dijk.

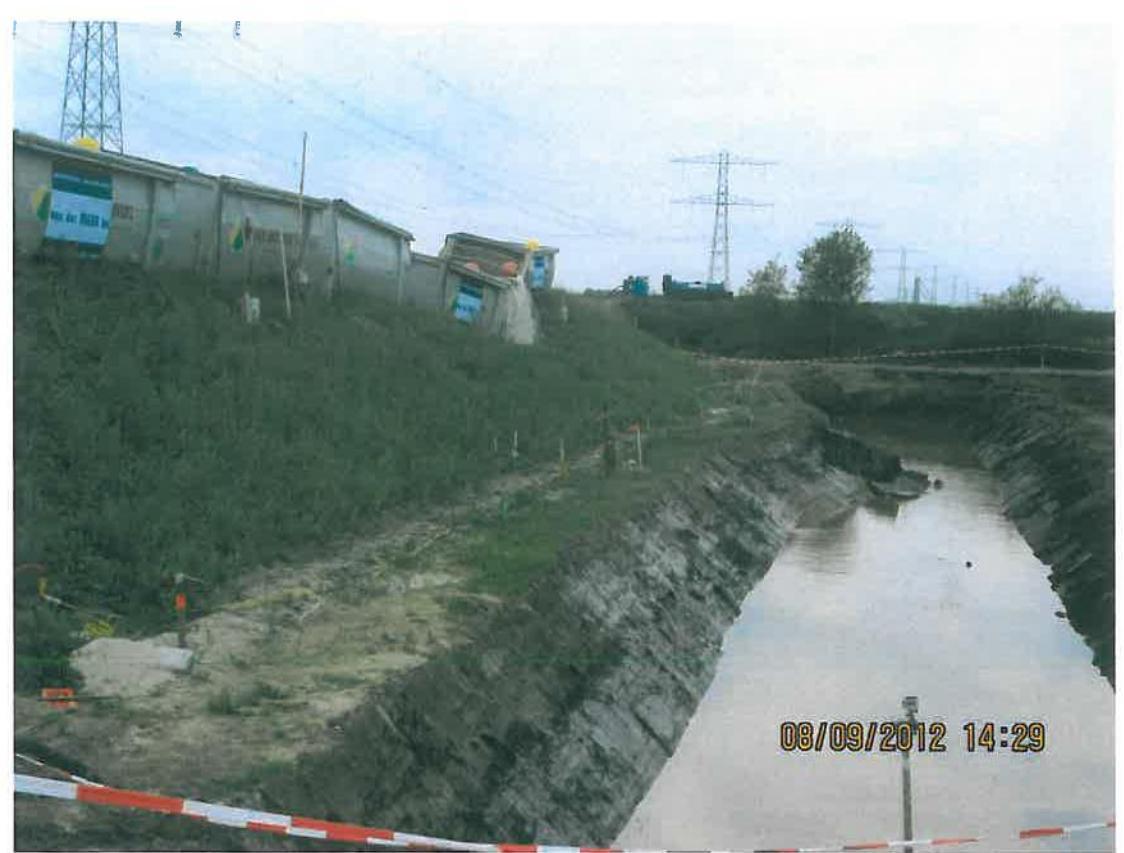
Foto 1879 – Openbarsten en verplaatsen van de slootkant. Inzakking van de dijk.

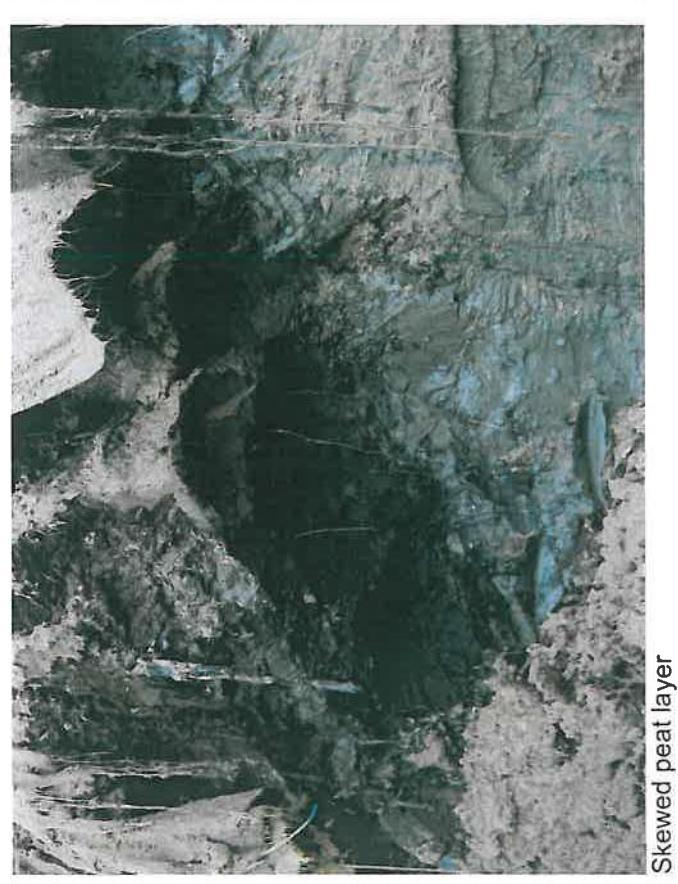
Failure plane at about NAP -2.5m, showing transitions of peat into clay layer

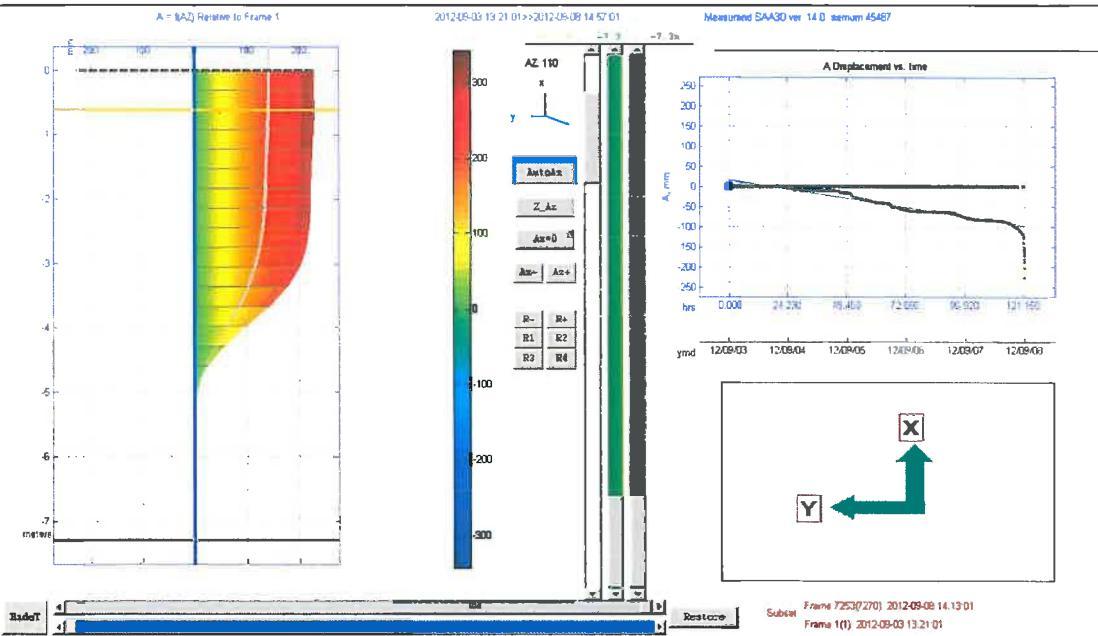
SAAF in East toe total deformation until t=122.30 hrs, gray line until t=122.02 hrs (maximum pore pressure)

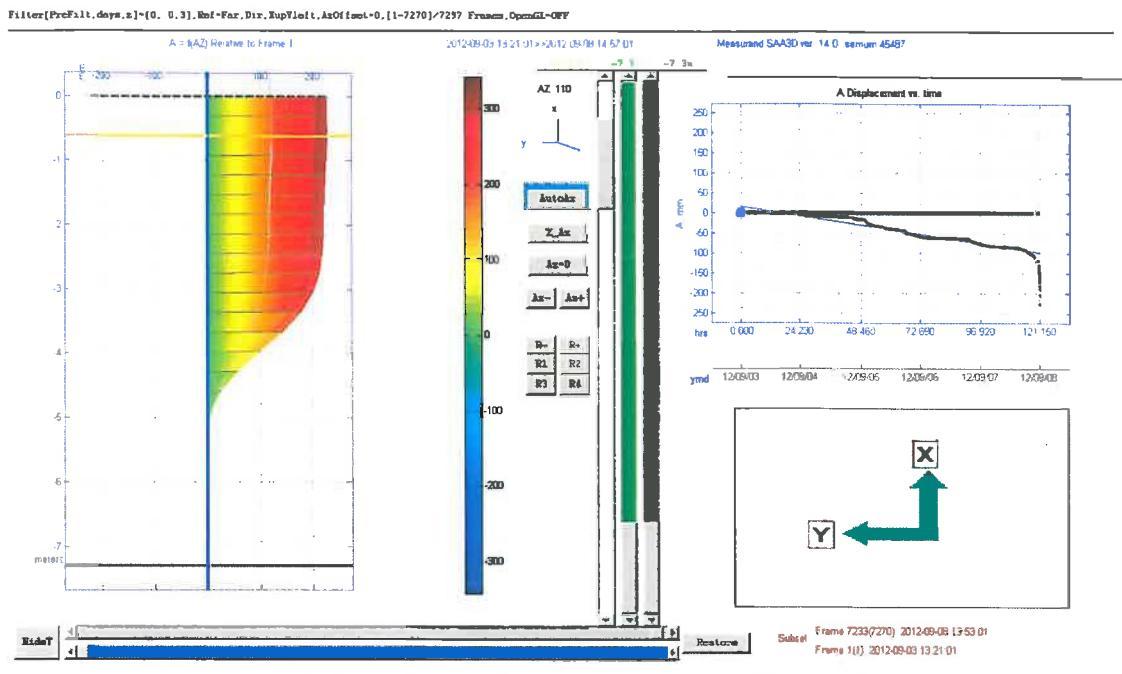
SAAF in East toe total deformation until t=122.30 hrs, gray line until t=121.69 hrs
