2012.09.05.6 IJKDIJK AIO-SVT GEOTECHNICAL ANALYSIS

2012.09.05.6 IJkdijk All-in-one Sensor Validation Test - Geotechnical Analysis

Stichting Flood Control

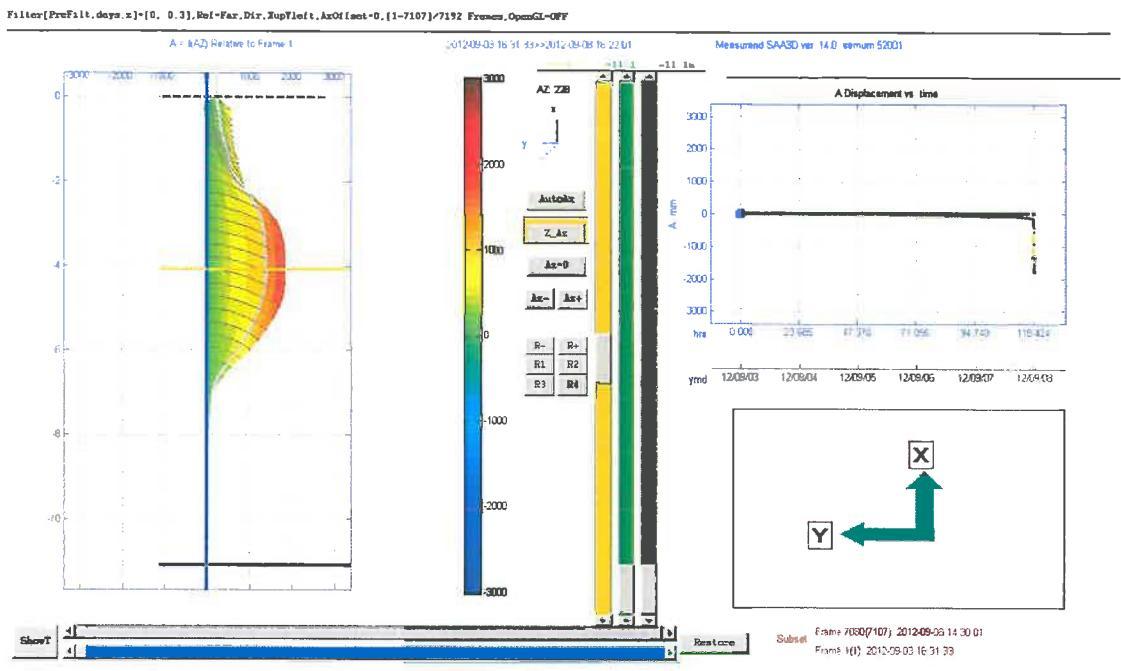
SAAF at middle under crest total deformation until t=122.75hrs, gray line until t=122.30 hrs

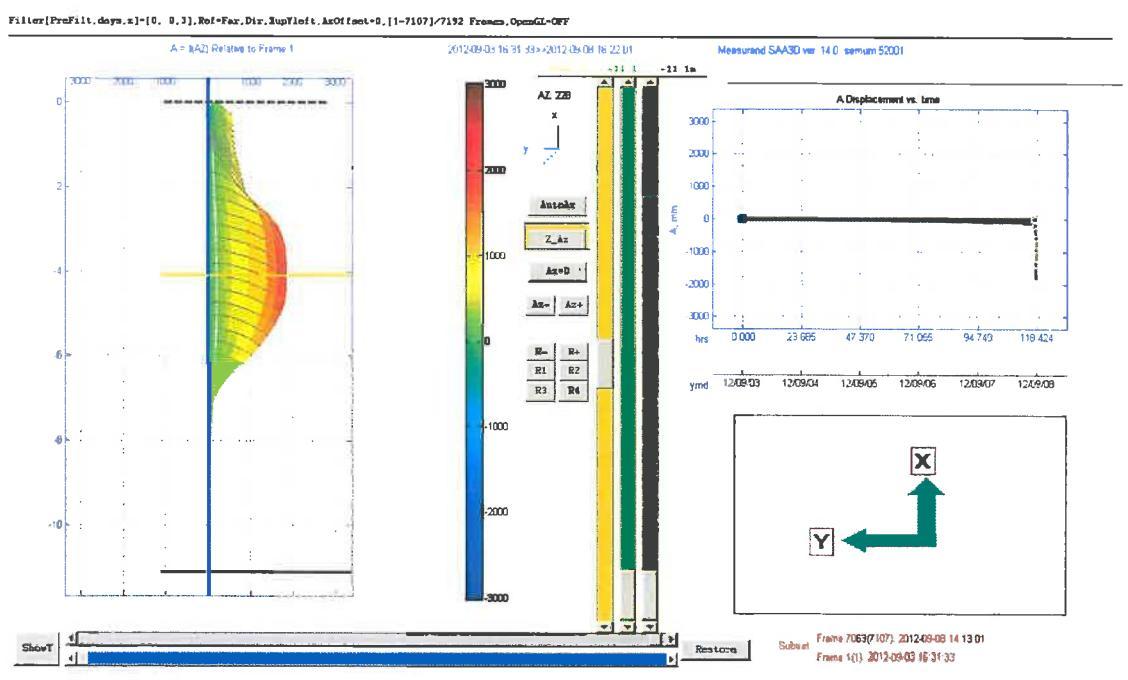
SAAF at middle under crest total deformation until t=122.30 hrs, gray line until t=122.02 hrs (maximum pore pressure)

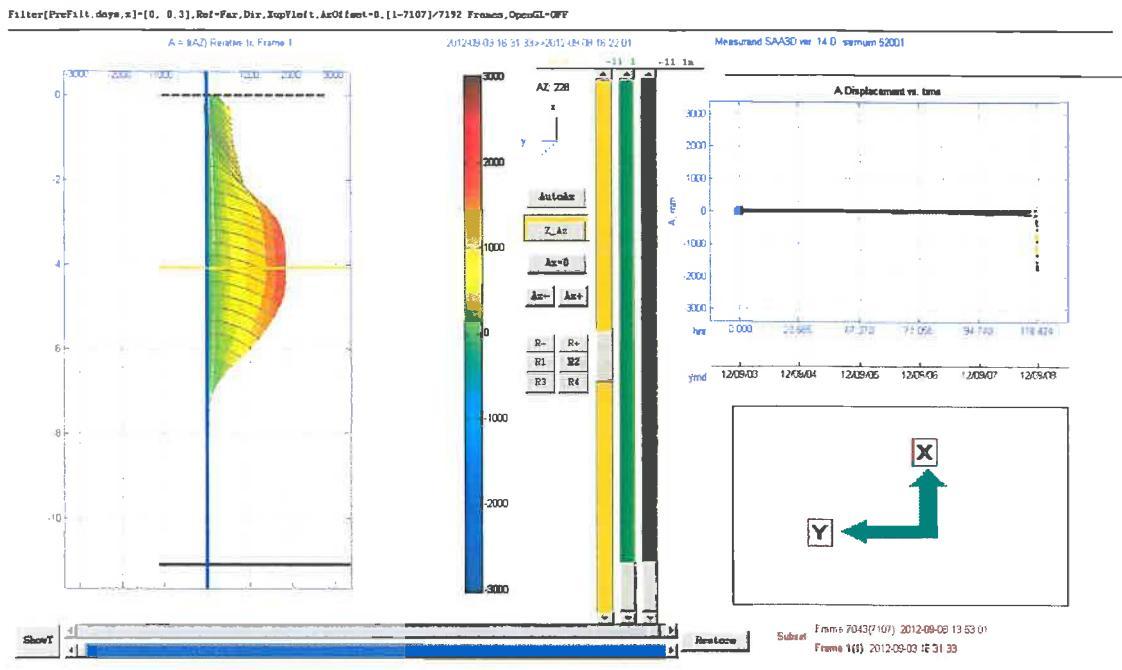
SAAF at middle under crest total deformation until t=122.30 hrs, gray line until t=121.69 hrs

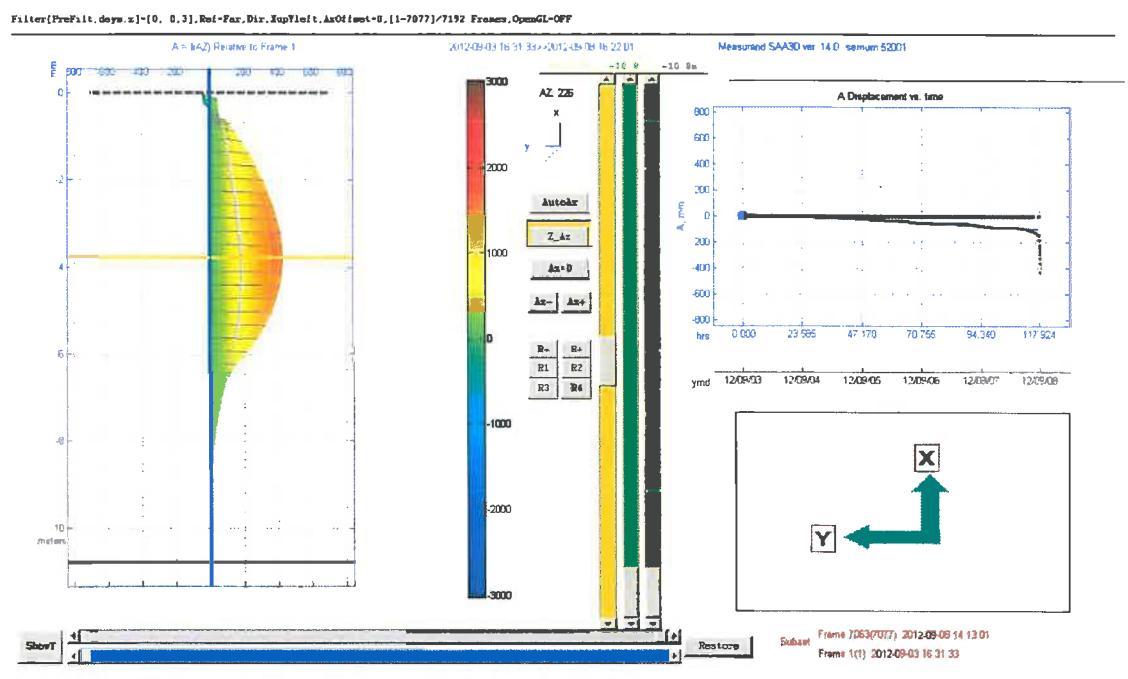
SAAF at middle under crest total deformation until t=122.02 hrs, gray line until t=121.69 hrs

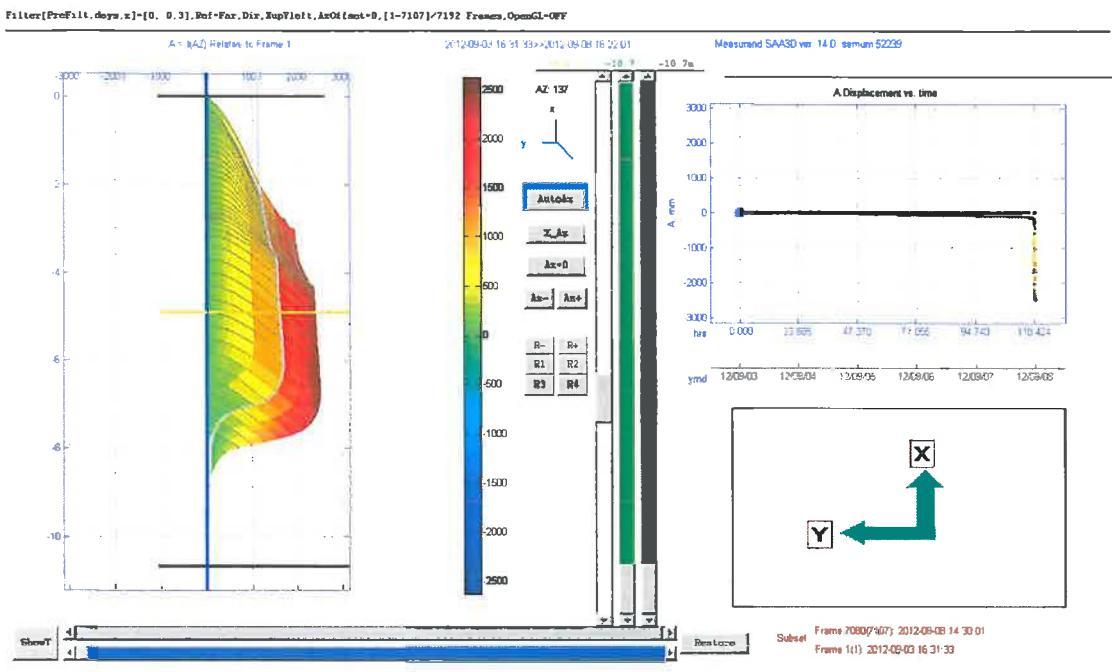
SAAF in front of toe at middle total deformation until t=122.75hrs, gray line until t=122.30 hrs

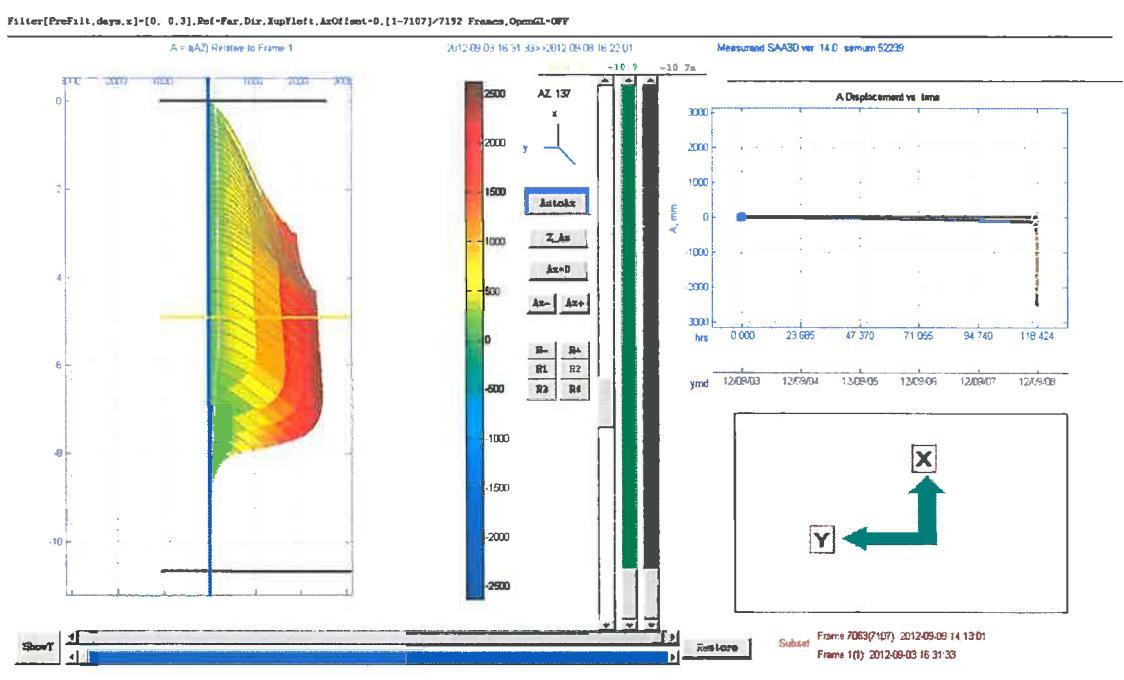
SAAF in front of toe at middle total deformation until t=122.30 hrs, gray line until t=122.02 hrs (maximum pore pressure)

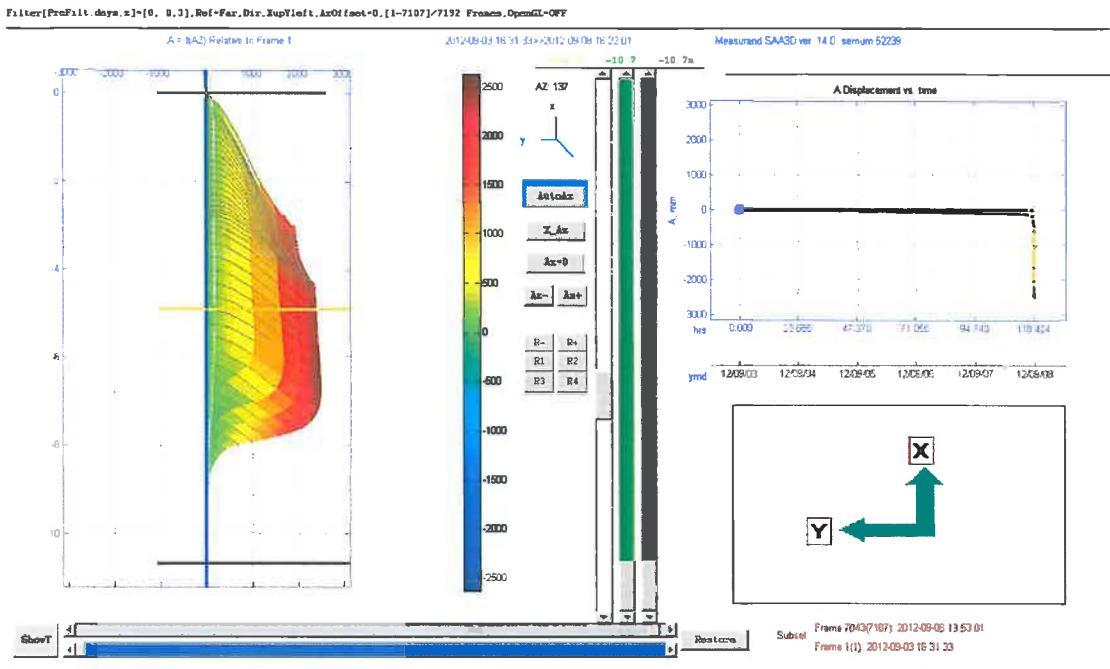
SAAF in front of toe at middle total deformation until t=122.30 hrs, gray line until t=121.69 hrs

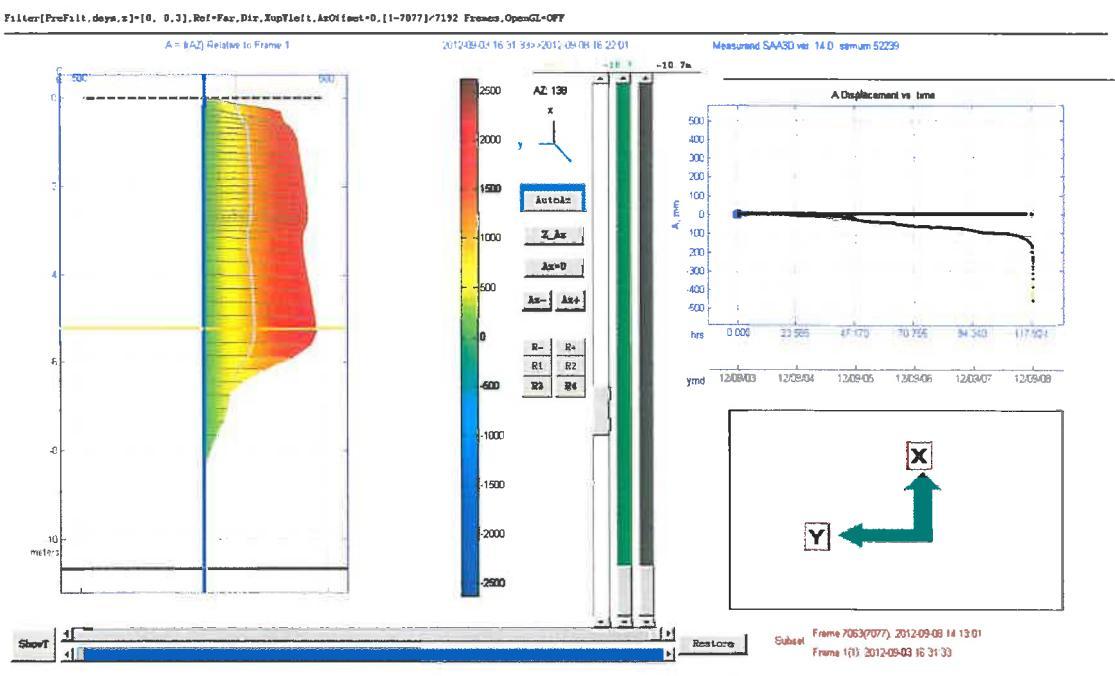
SAAF in front of toe at middle total deformation until t=122.02 hrs, gray line until t=121.69 hrs

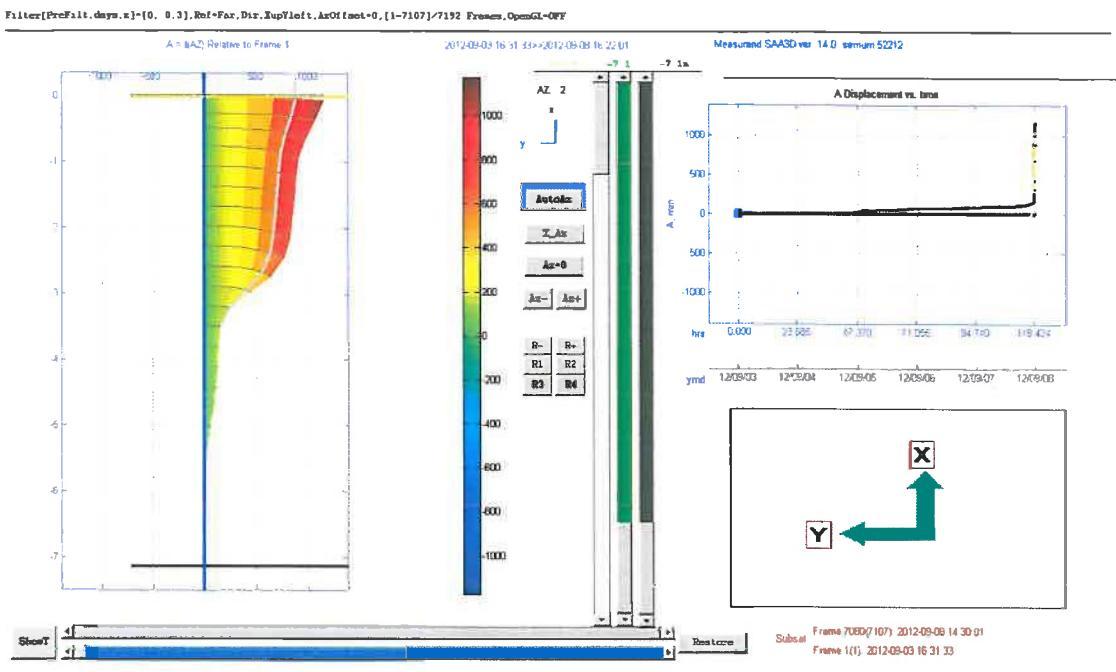
SAAF in front of West toe total deformation until t=122.75hrs, gray line until t=122.30 hrs

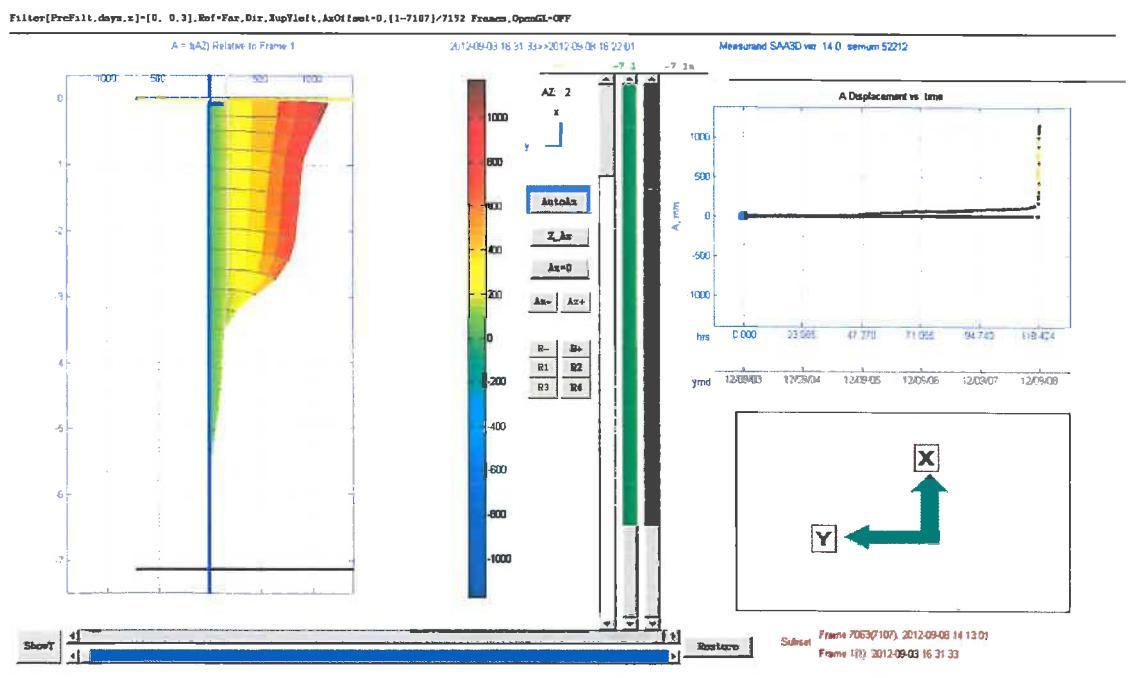
SAAF in front of West toe total deformation until t=122.30 hrs, gray line until t=122.02 hrs (maximum pore pressure)

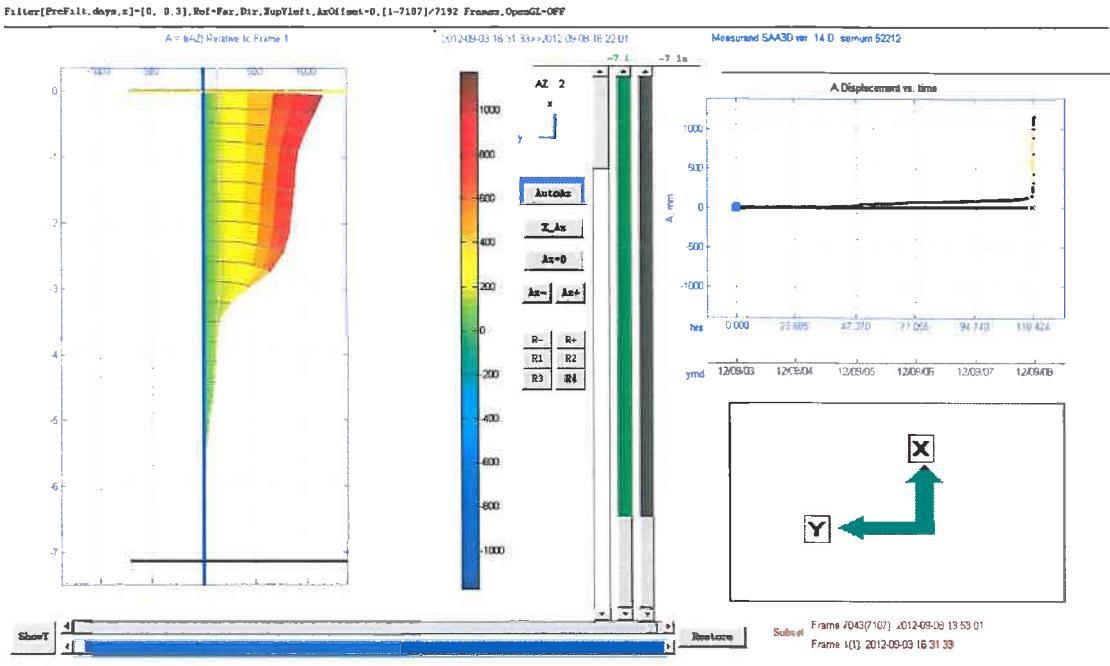
SAAF in front of West toe total deformation until t=122.30 hrs, gray line until t=121.69 hrs

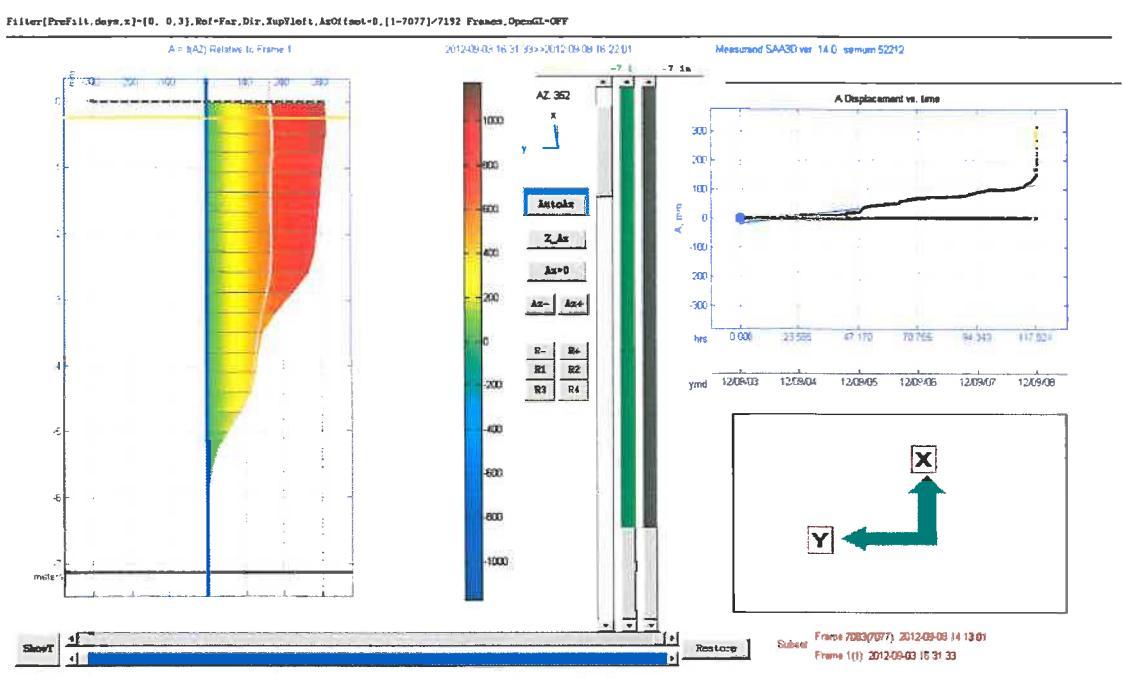
SAAF in front of West toe total deformation until t=122.02 hrs, gray line until t=121.69 hrs

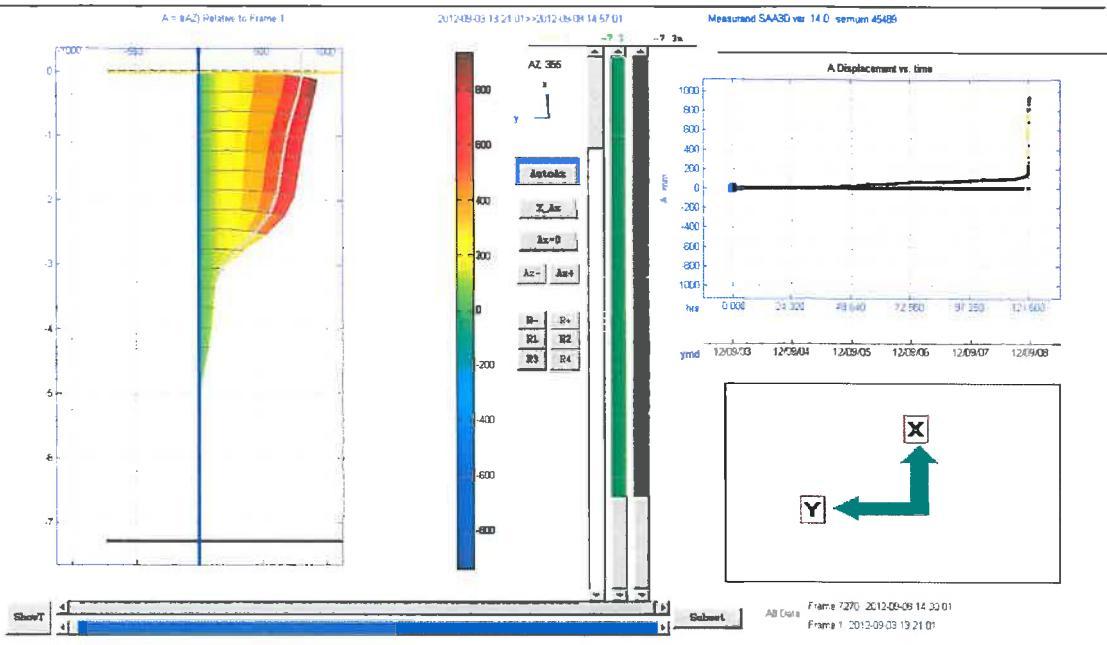
SAAF in West toe total deformation until t=122.75hrs, gray line until t=122.30 hrs

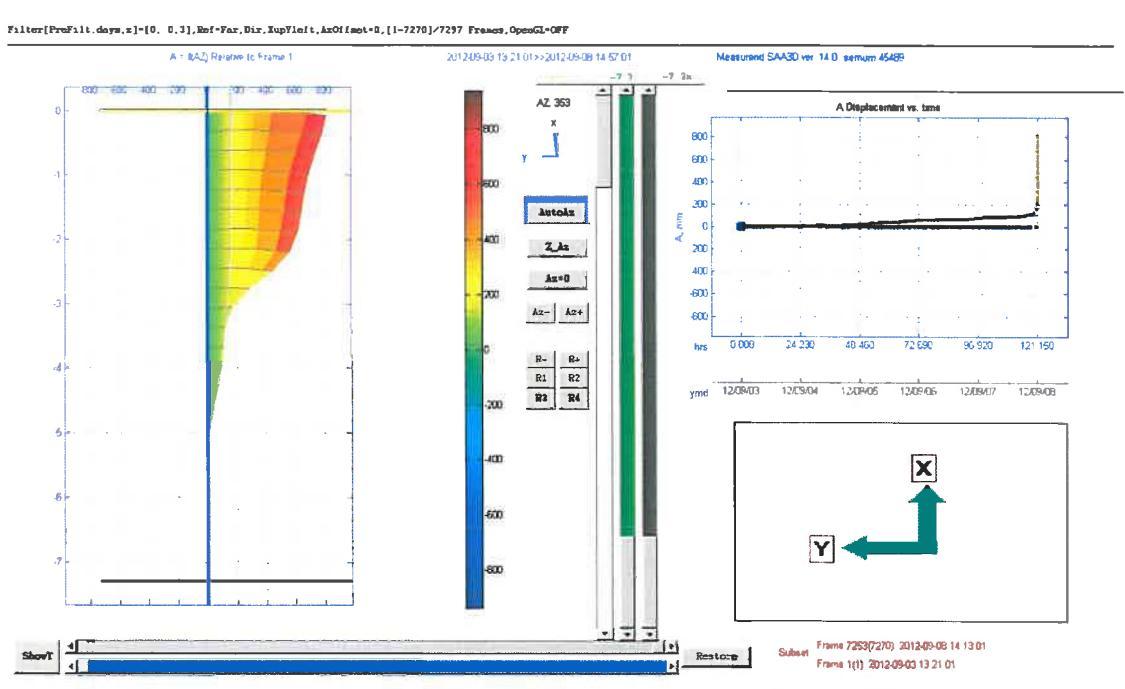
SAAF in West toe total deformation until t=122.30 hrs, gray line until t=122.02 hrs (maximum pore pressure)

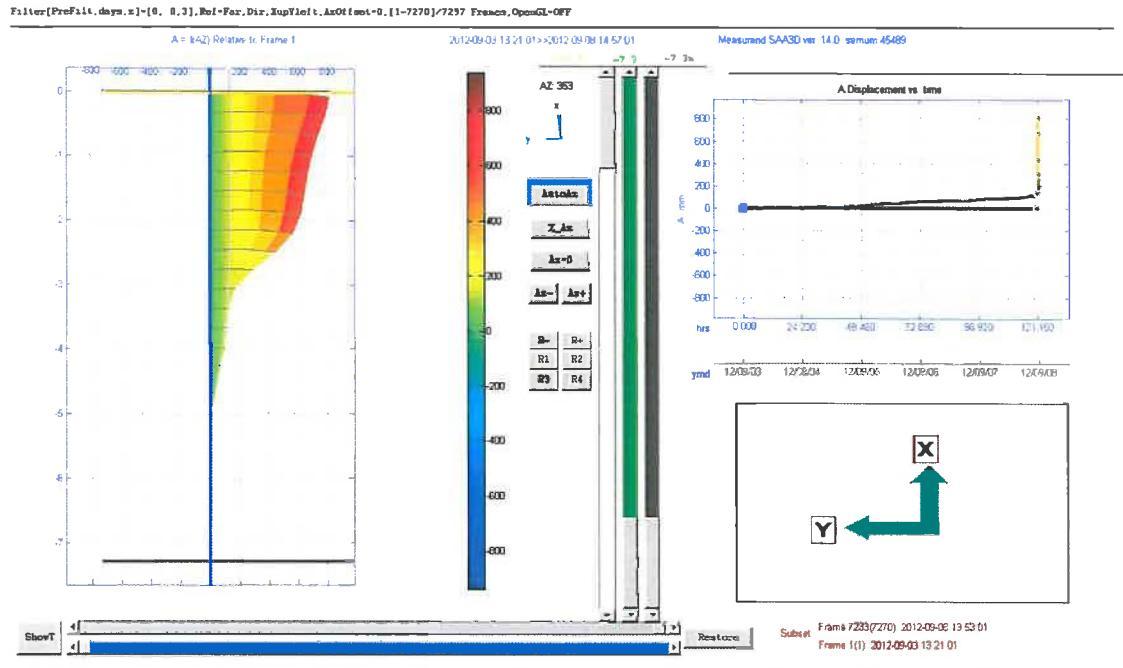
SAAF in West toe total deformation until t=122.30 hrs, gray line until t=121.69 hrs

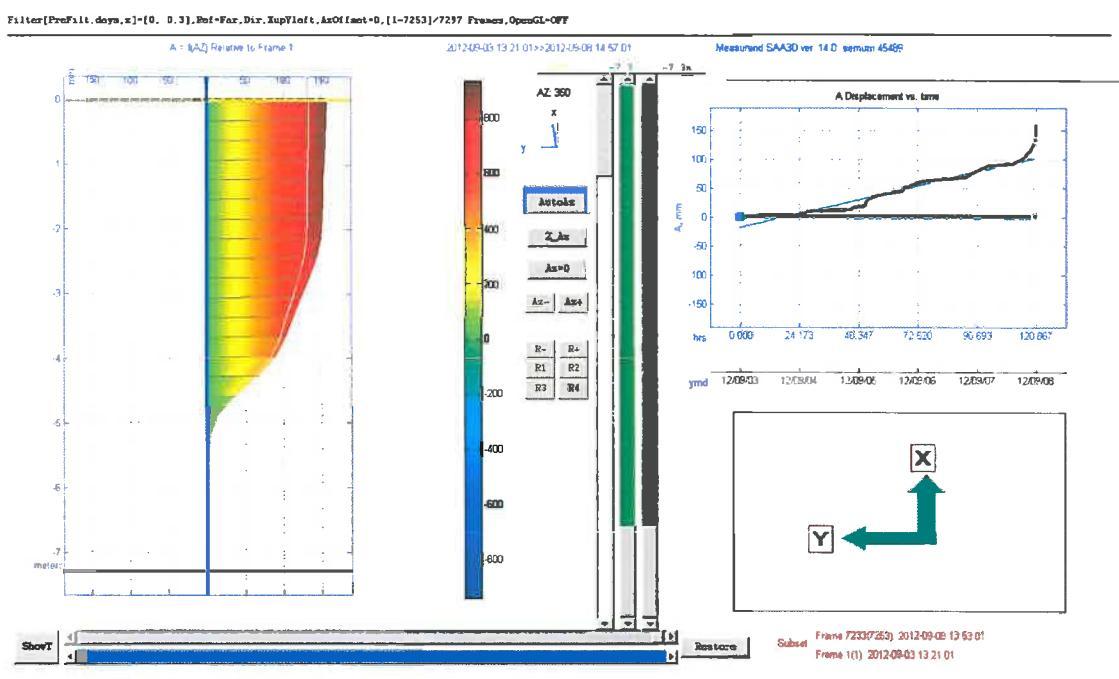
SAAF in West toe total deformation until t=122.02 hrs, gray line until t=121.69 hrs

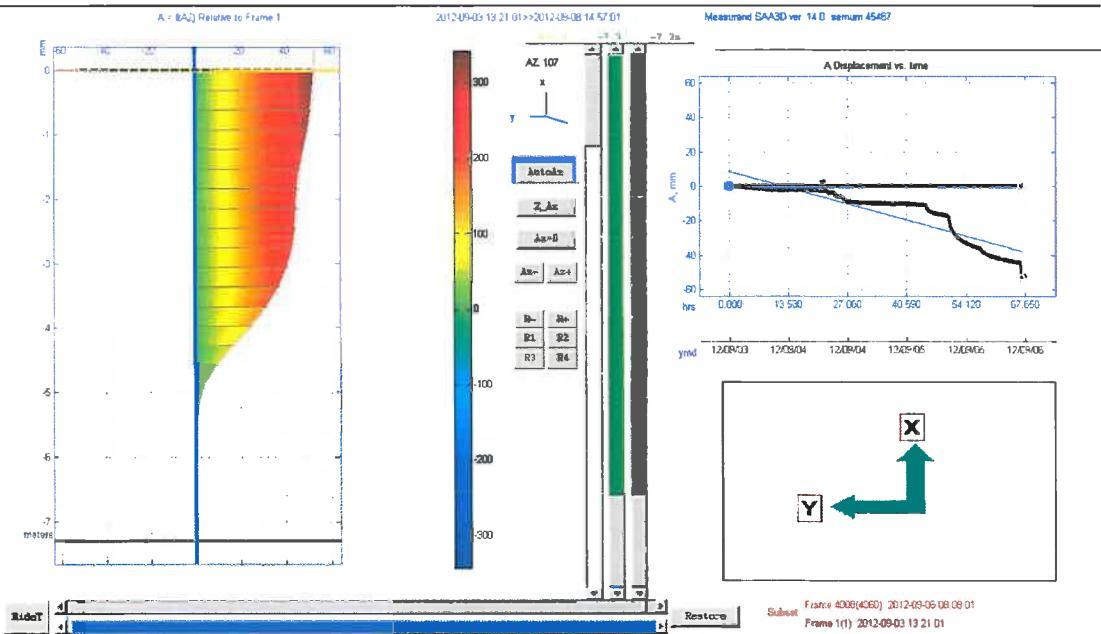
SAAF in East toe total deformation until t=68.80 hrs, gray line until t=67.93 hrs

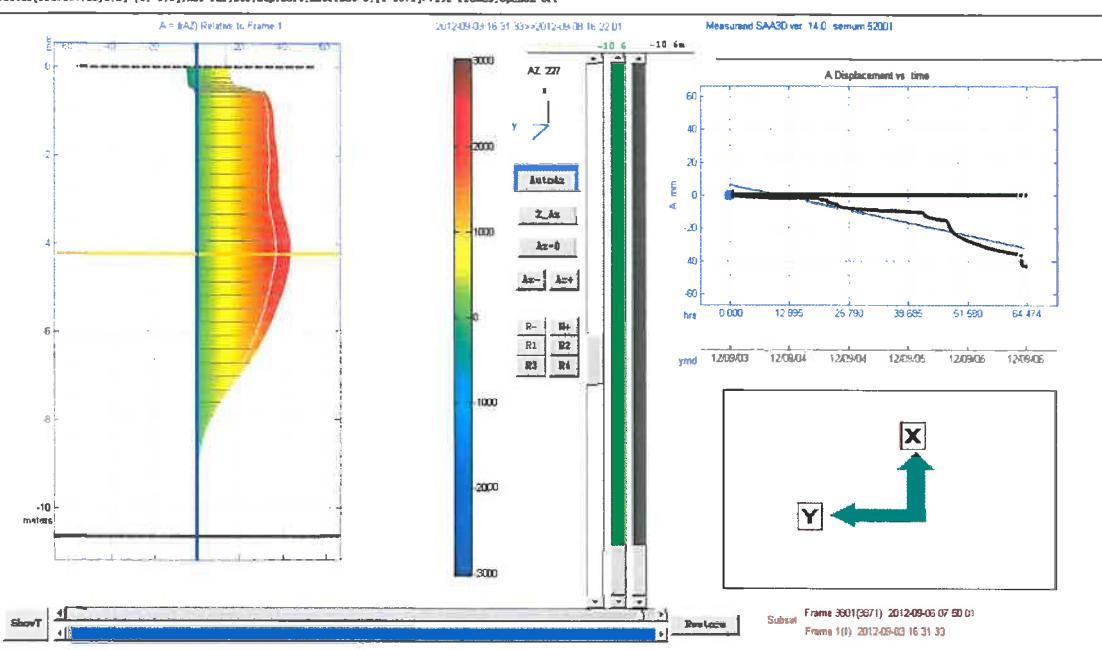
SAAF at middle under crest total deformation until t=68.80 hrs, gray line until t=67.63 hrs

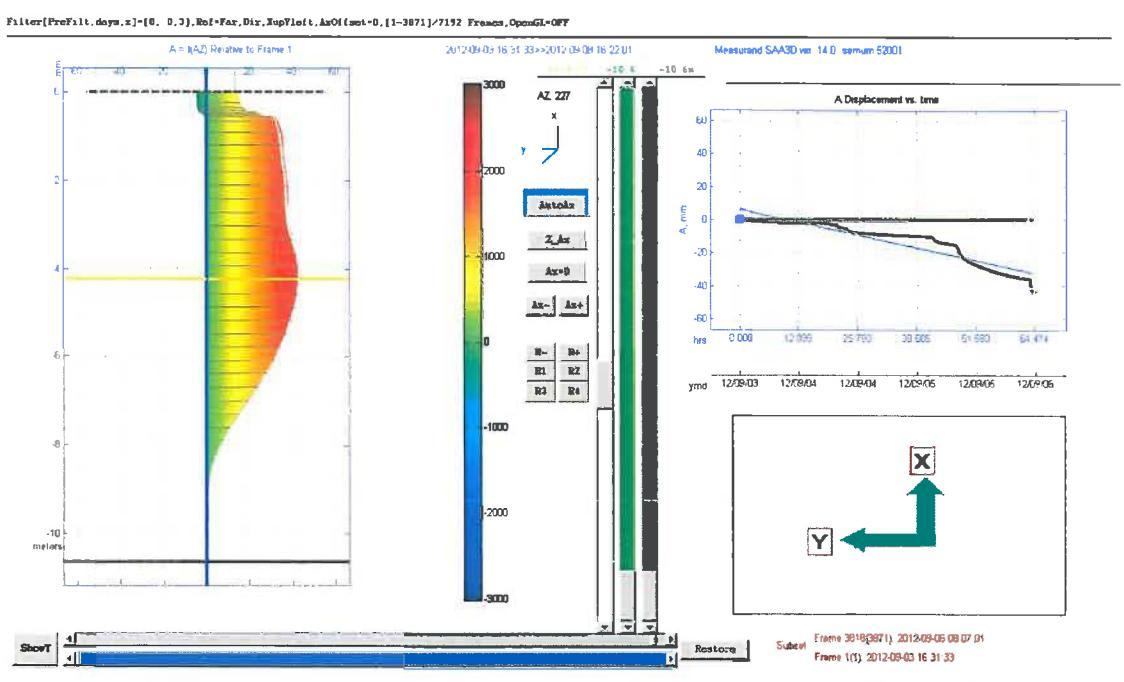
SAAF at middle under crest total deformation until t=68.80 hrs, gray line until t=67.92 hrs

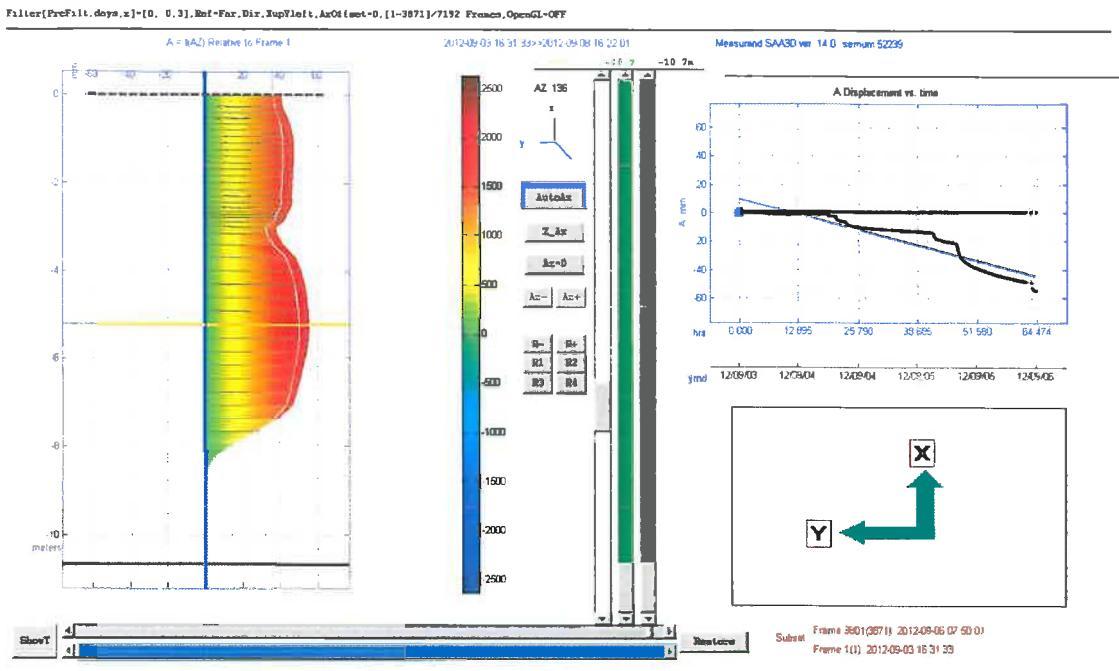
SAAF in front of toe at middle total deformation until t=68.80 hrs, gray line until t=67.63 hrs

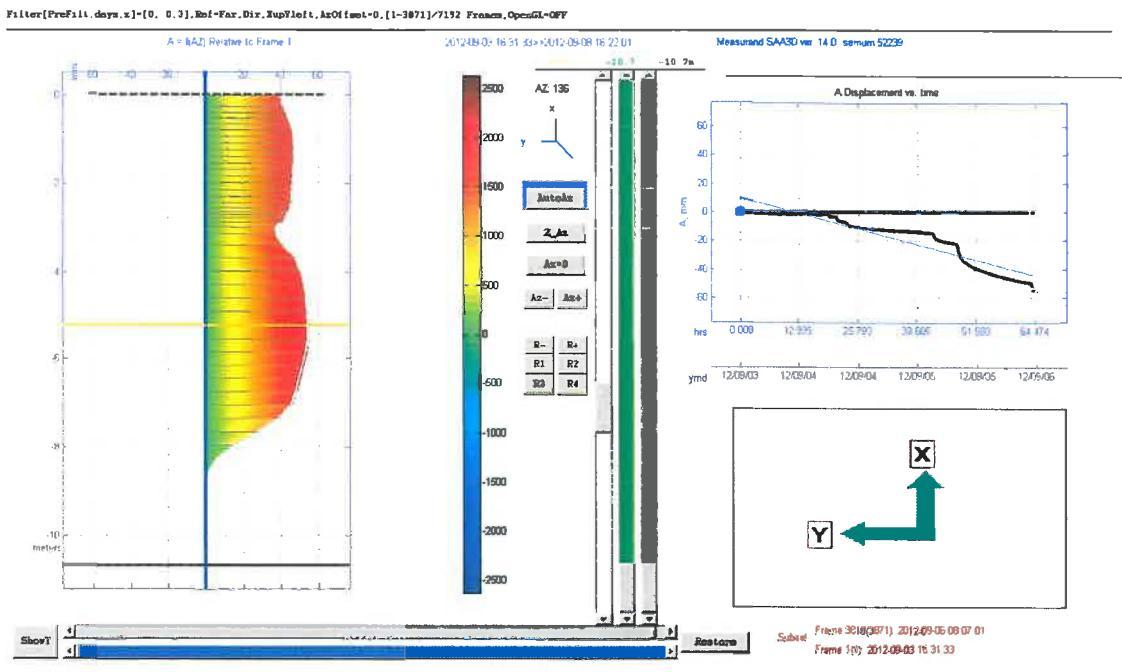
SAAF in front of toe at middle total deformation until t=68.80 hrs, gray line until t=67.92 hrs

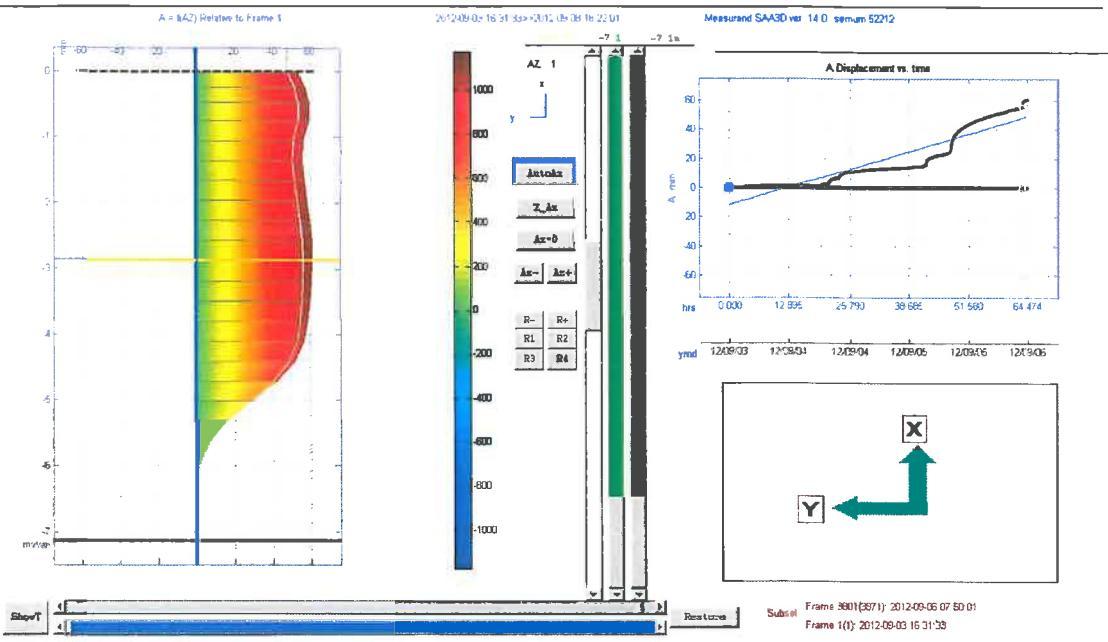
SAAF in front of West toe total deformation until t=68.80 hrs, gray line until t=67.63 hrs

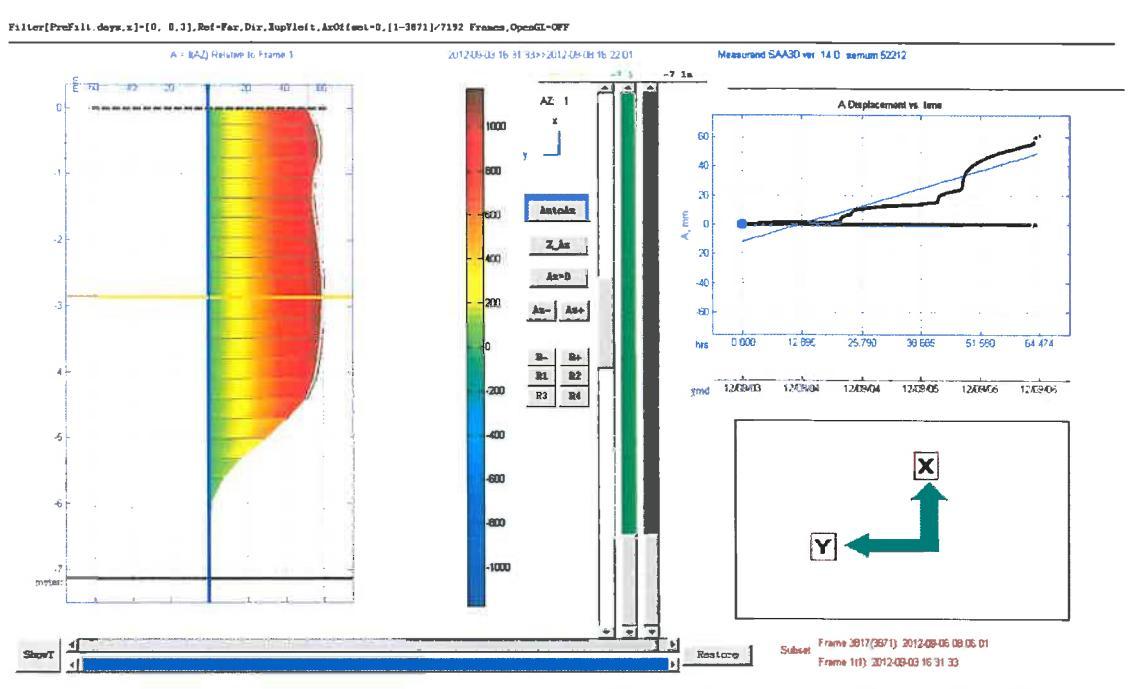
SAAF in front of West toe total deformation until t=68.80 hrs, gray line until t=67.90 hrs

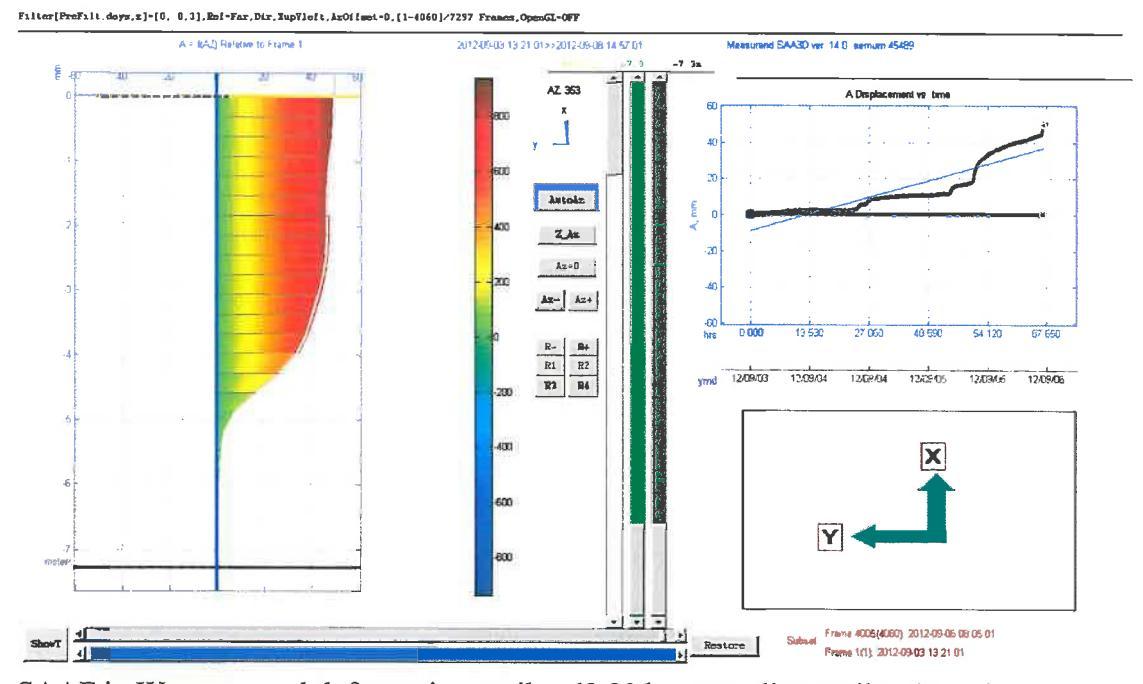
SAAF in West toe total deformation until t=68.80 hrs, gray line until t=67.88 hrs
